# Summary of Spring Flow Decline and Local Hydrogeologic Studies, 1969-2007

## *Pipe Spring National Monument*

Natural Resource Report NPS/NRPC/WRD/NRTR—2007/365

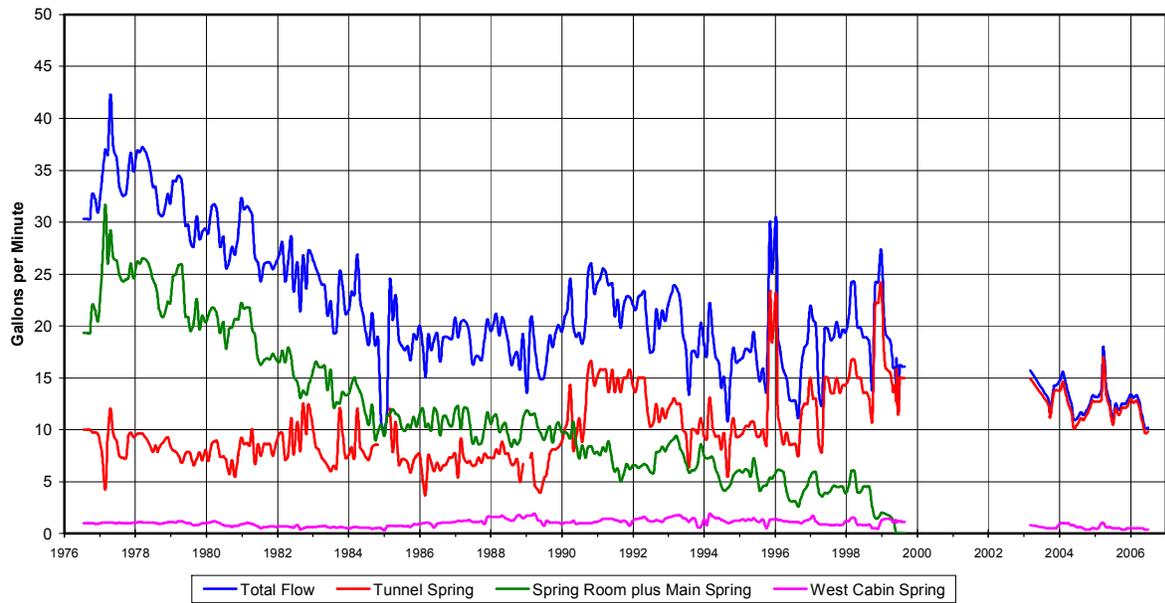
Figure 4. Spring flow at Pipe Spring National Monument.

Figure 4 shows the monthly spring flow data for each of the springs. Most of the decreased outflow from the springs from 1976-85 was a result of declining flow from the courtyard cistern to Main Spring and Spring Room Spring. Total flow was fairly steady from 1986-90. After 1990, flow from Tunnel Spring increased and flow from the courtyard cistern decreased. In mid-1999, flow from the courtyard cistern ceased and there has been no natural flow at Main Spring or Spring Room Spring since then. A system of pumps and pipes has been constructed to pump water from Tunnel Spring to Main Spring and Spring Room Spring to recreate the historical scene. About 90% of the total spring flow at Pipe Spring now occurs from Tunnel Spring. Flow from West Cabin Spring has remained fairly steady between about ½-1½ gpm throughout the monitoring period.

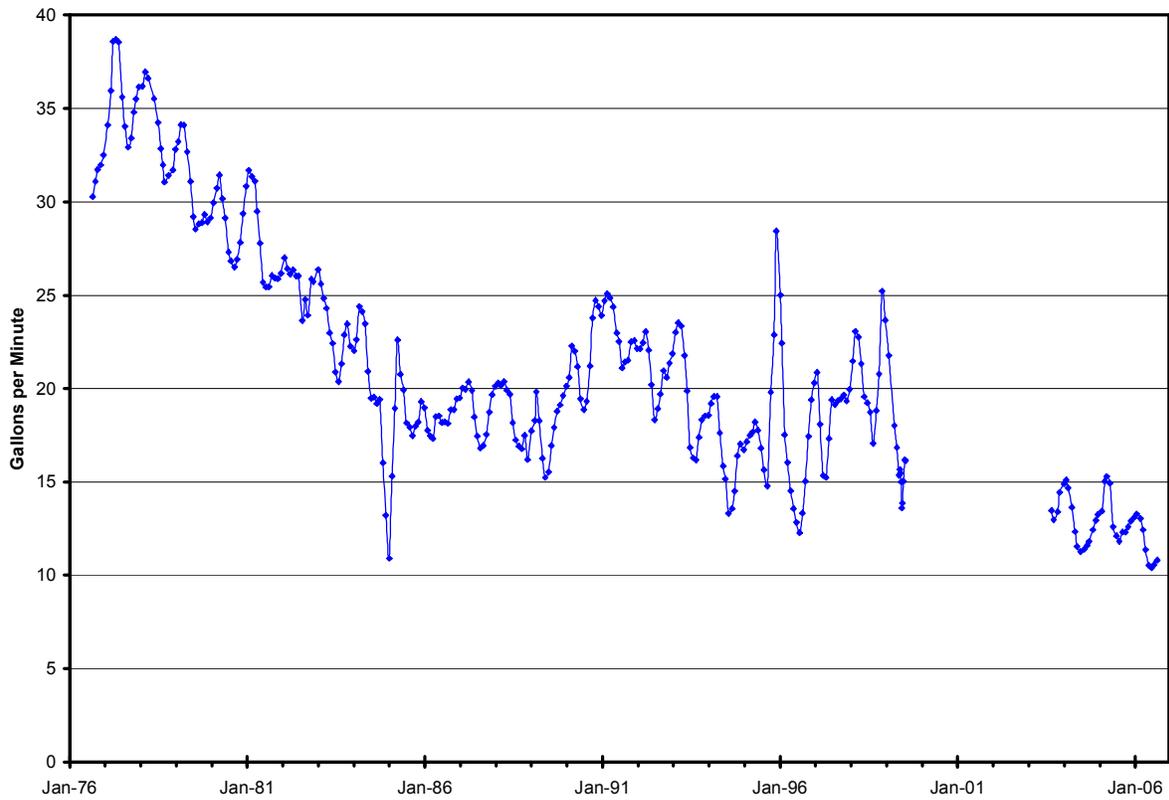
Figure 5. Total spring flow at Pipe Spring National Monument, three month running average.

It is a little easier to illustrate the spring flow patterns at Pipe Spring by looking at the total combined flow from all of the springs (Figure 5). Some of the “spikiness” has been removed from the data by plotting it as a 3-month running average. The flow data for each month is the average of the previous month, the current month, and the following month. These data show an annual pattern with highest flow in late-winter to early-spring and the lowest flow in summer to early-autumn. Several years of above average precipitation (and therefore greater recharge to the aquifer system) may partially explain the slowing of the rate of decline during the 1990s.

It was not possible to monitor spring flow during (and for some period after) the reconstruction of Tunnel Spring until the new weir box was installed at the mouth of the tunnel. Regular monthly monitoring resumed in September 2003. Since then, total flow has varied from 10-15 gpm. There is a continuing trend of decreasing spring flow.

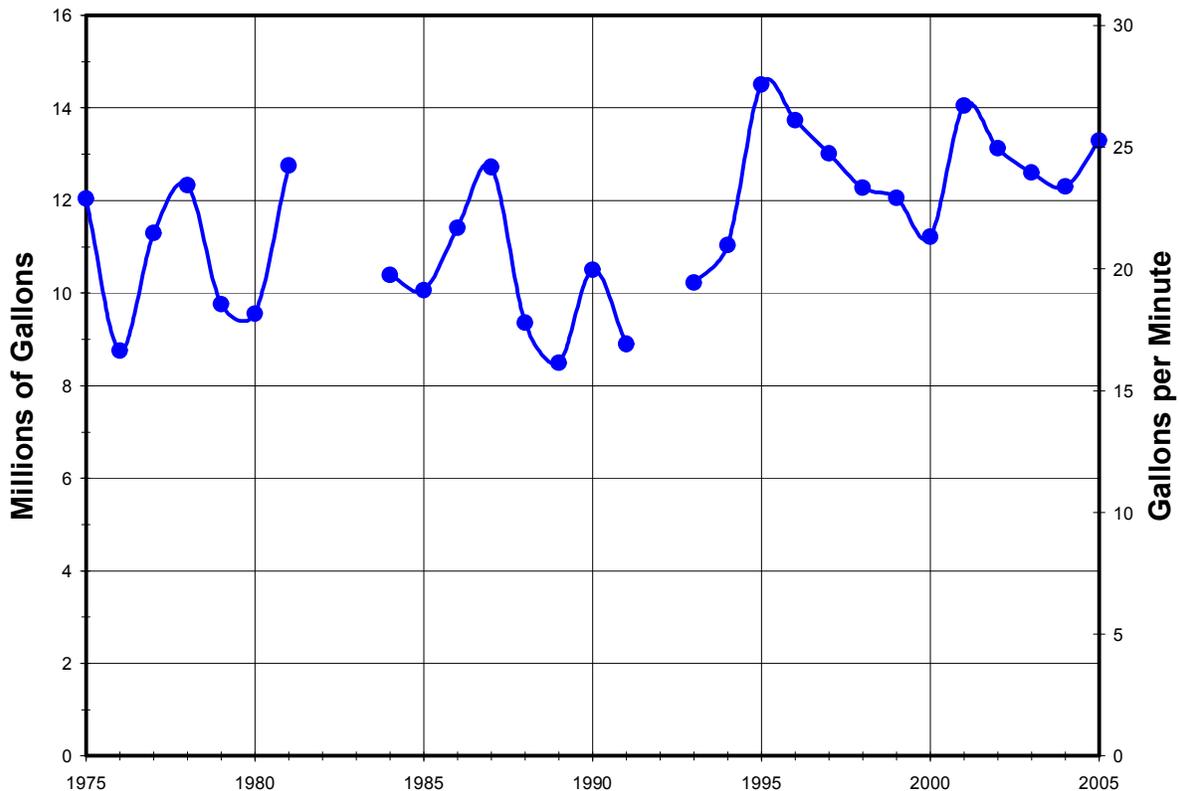
Figure 15. Annual groundwater pumping from the NPS supply well.

The NPS Supply Well is completed in the fracture zone associated with the West Branch of the Sevier Fault and is located about 2 miles north of the monument (Figure 18). The well supplies water for NPS facilities at the monument, the Tribal-NPS partnership visitor center, and Tribal facilities south of Juniper Village. These facilities include: the Tribal multi-purpose building, campground, NPS administrative offices, Tribal Court building, Red Hills Village, Red Cliffs gas station and convenience store, Tribal administration offices, and all facilities at the monument. The well has been in use since June 1973. Annual groundwater pumping from the NPS Well is shown on Figure 15. Over the past 10 years, water use for this system has ranged from about 12-14 million gallons per year (mgy). The midpoint of this demand, 13 mgy is equivalent to 25 gallons per minute (gpm).

From mid-April to mid-June 2006, the Tribal Supply Well was shut down for repairs. During this time the NPS Well supplied all of the demand of Tribal and NPS facilities, including Juniper and Kaibab Villages. During the early part of this period, the weather was cool and water demand was low. During the latter part of the period, water demand increased as the temperature rose, and more water was used for outdoor watering. Average daily use for all NPS and Tribal consumption during the two-month period was 88,400 gallons per day, or 60 gpm (Terry Strong, pers. comm.). Lacking more definitive data, this may be a good indicator of the average current combined use by NPS and the Tribe during that part of the year.

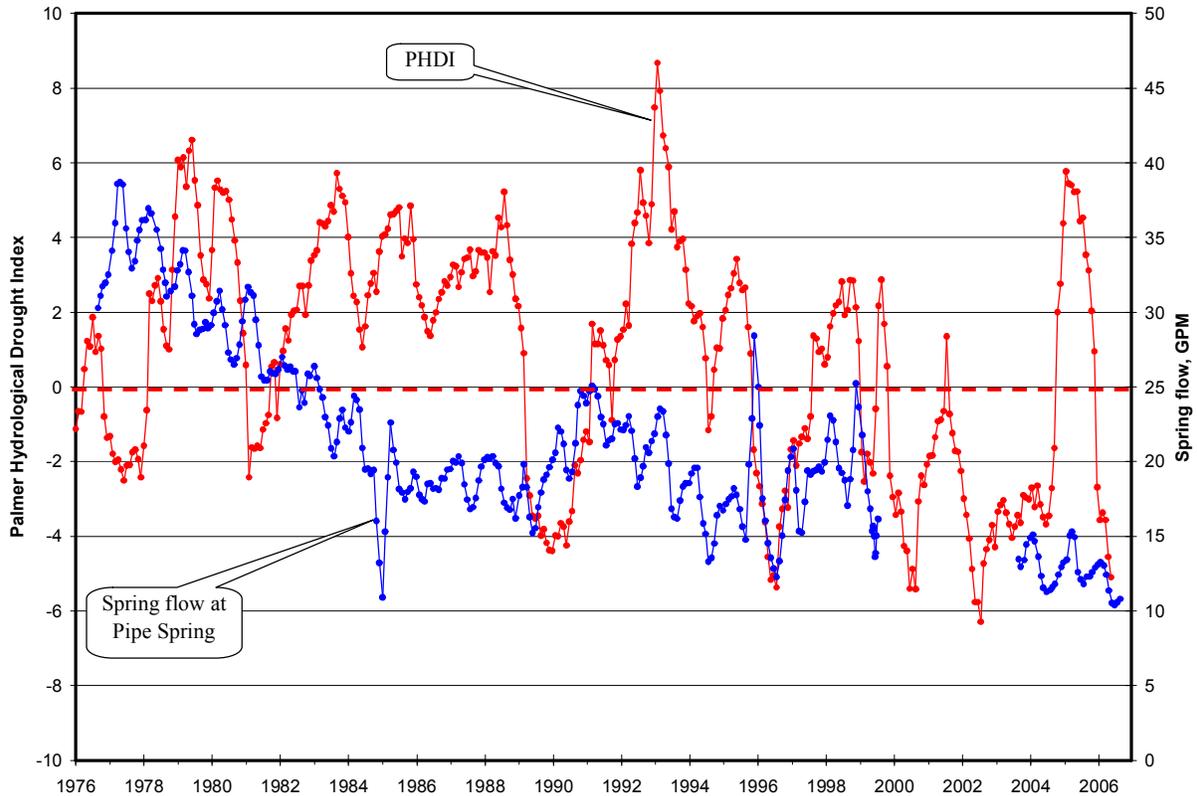
Figure 17. Comparison of Palmer Hydrological Drought Index and spring flow at Pipe Spring.

Comparison of the drought index and spring flow data shows poor correlation, leading to the conclusion that the observed spring flow decline at Pipe Spring National Monument is not a result of natural drought. For example, during much of the period from 1976-85, when the spring flow was declining at its highest rate, the drought index was positive, indicating wetter than average conditions. In 1989-90, when spring flow was increasing, the area was experiencing a severe drought. A wetter than normal period in 2005 had no apparent effect on spring flow.

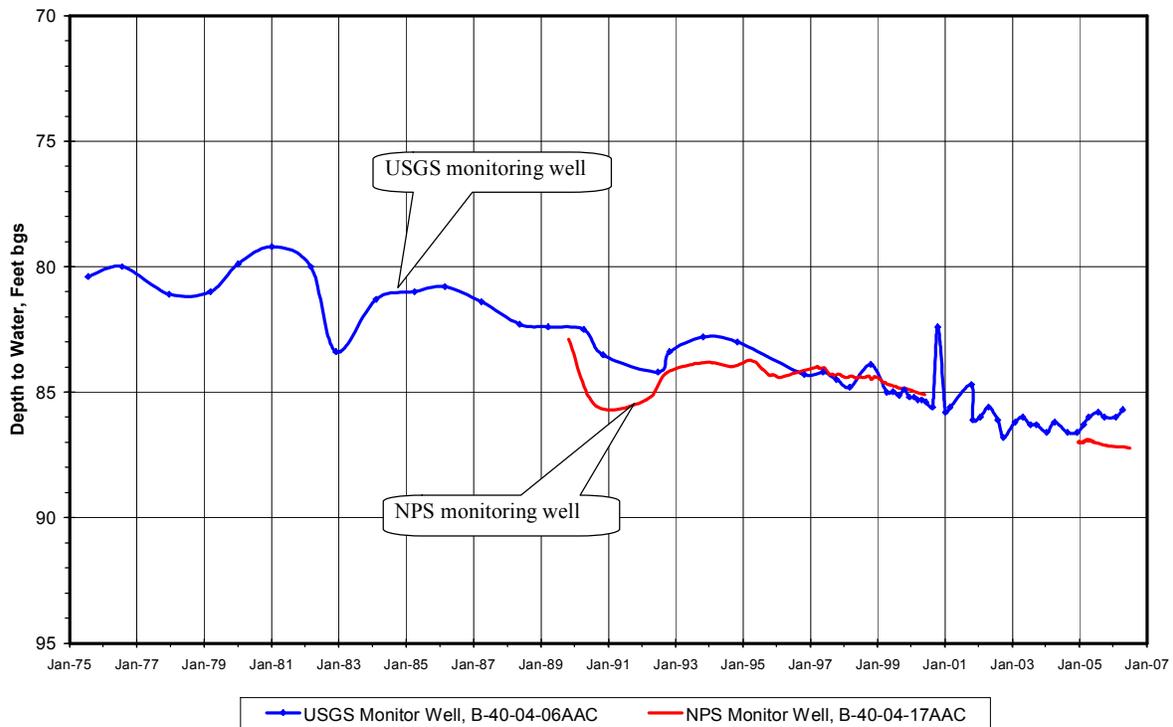
Figure 19. Water levels in monitoring wells north of Pipe Spring.

Water levels in both monitoring wells show a general decline of about a third of a foot per year (Figure 19). Water levels in the immediate vicinity of the supply wells have not been regularly measured. The observed water table decline at the two monitoring wells, both about a mile from the supply wells, indicates a general decline of the water level in the aquifer encompassing a large area. This decline may be the cause of spring flow decline at Pipe Spring. As the water level in the aquifer is lowered, there is less of an elevation change between the water level in the aquifer and the springs, and therefore, it would be expected that discharge at the springs would decrease.

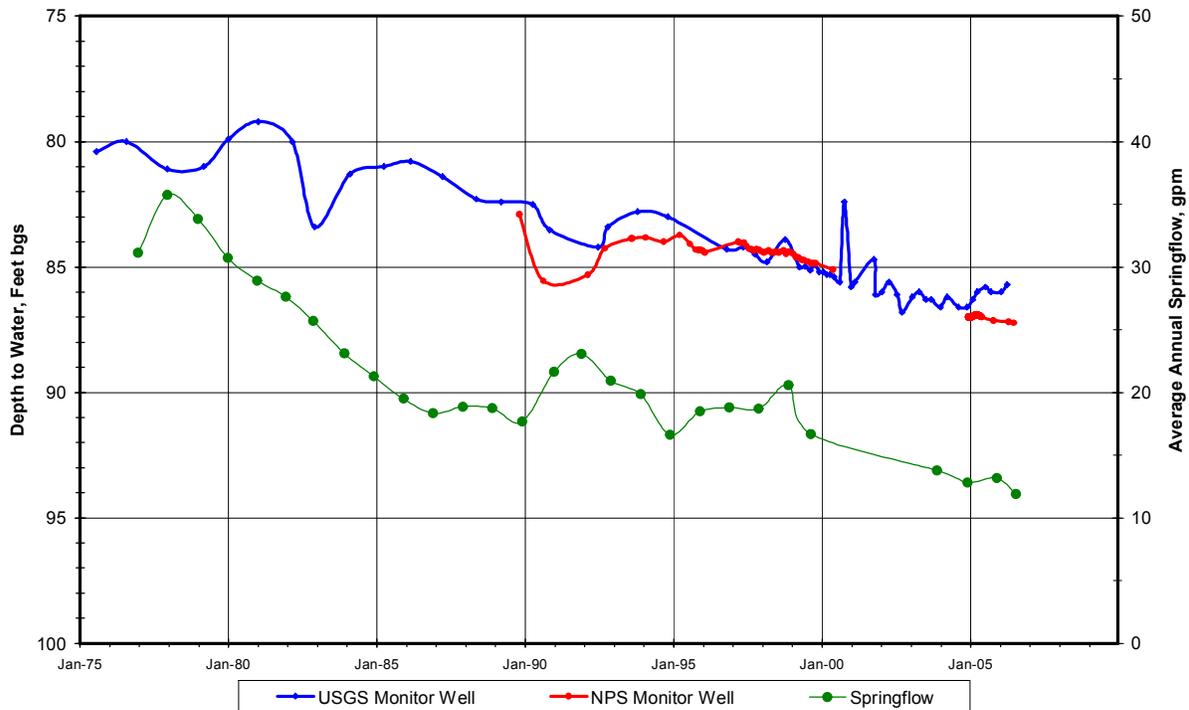
Figure 21. Graph showing water table decline and spring flow decline in the Pipe Spring area.

Continued pumping from the NPS and Tribal potable supply wells is likely the major cause of spring flow decline at Pipe Spring. It is almost certain that spring flow will continue to decline and eventually cease unless the water supply wells are relocated north of Moccasin Wash or some alternative source of water is developed.

Perhaps nothing illustrates and summarizes the problem better than a graph showing the rate of decline of the water table and the rate of decline of spring flow at Pipe Spring (Figure 21). If we don't change anything, if the Tribe and NPS continue to pump groundwater at the current well sites, the water table will continue to decline and spring flow will continue to decline. Eventually the springs will cease flowing.
