AN ASSESSMENT OF RIPARIAN AND UPLAND CONDITIONS ON GRAZING ALLOTMENTS AT LAKE ROOSEVELT NATIONAL RECREATION AREA, WASHINGTON

Technical Report NPS/NRWRD/NRTR-2005/329

April 2005

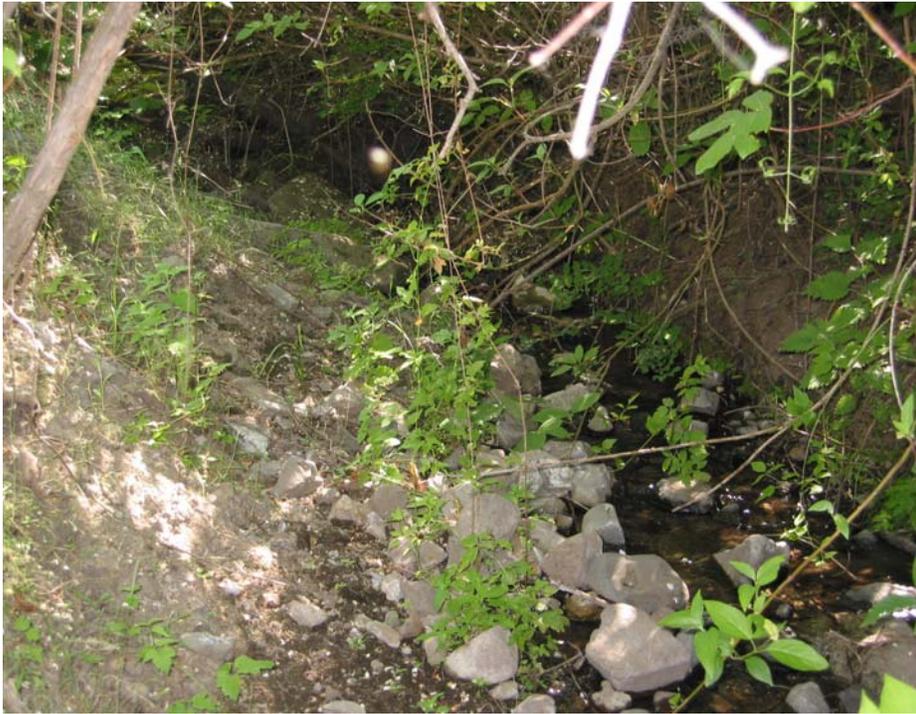
Figure 2. Rosenberg Reach #2 stream channel

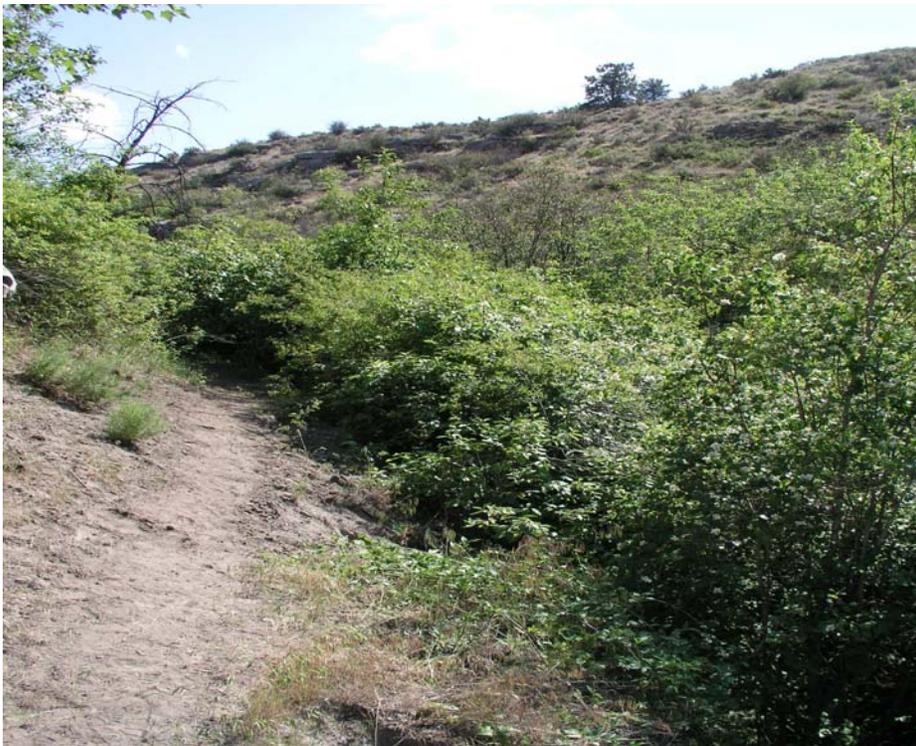
Figure 3. Rosenberg Reach #2 - sediment inputs from trail

Management recommendations: Current livestock management appears to be compatible with maintenance of a “properly functioning” riparian system in this reach. If practical, we recommend that measures be taken to discourage livestock from trailing along the edge of the channel to avoid destabilization by hoof action (a source of sediment inputs) and direct input of nutrients from defecation.

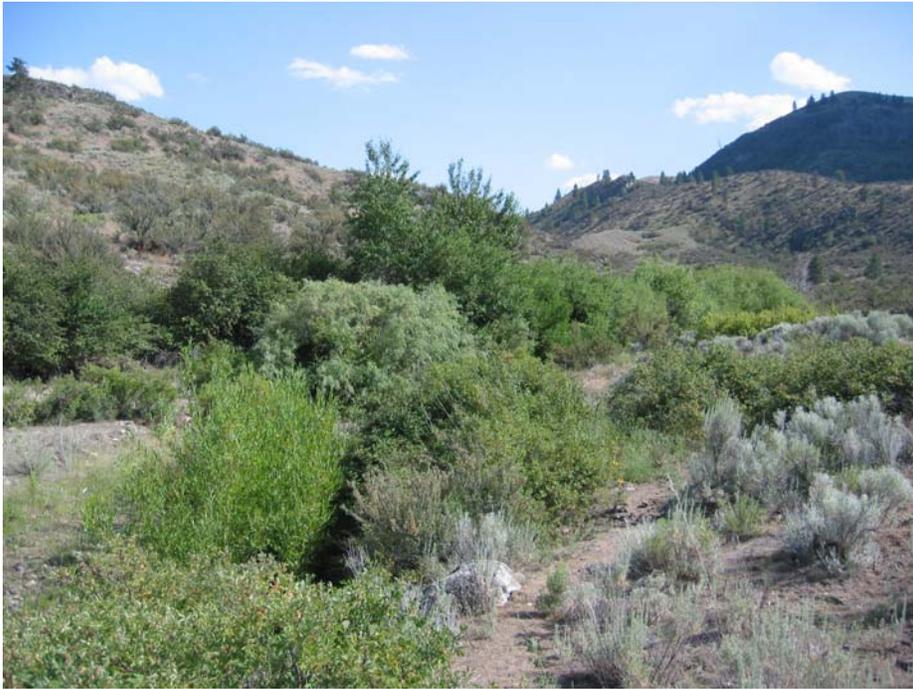
The team rated this stream reach as being in **Proper Functioning Condition** based on a channel-floodplain form and a healthy riparian wetland vegetation community that provide ample ability to withstand moderate to large floods without undue erosion or loss of habitat structure (see PFC checklist and notes in Appendix 1). However, we note that channel stability in this moderate-grade alluvial system is highly dependent upon continued maintenance of the current healthy riparian-wetland vegetation community. The site could become “At-Risk” if additional grazing pressure began to degrade these vegetation characteristics.

Figure 4. Green Riparian Assessment Reach (Kaufman Canyon)

Management recommendations: Current livestock management appears to be compatible with maintenance of a functional riparian system in this reach. We recommend that the park maintain the current level of vegetation community health by not extending grazing any further into the growing season than current management allows.

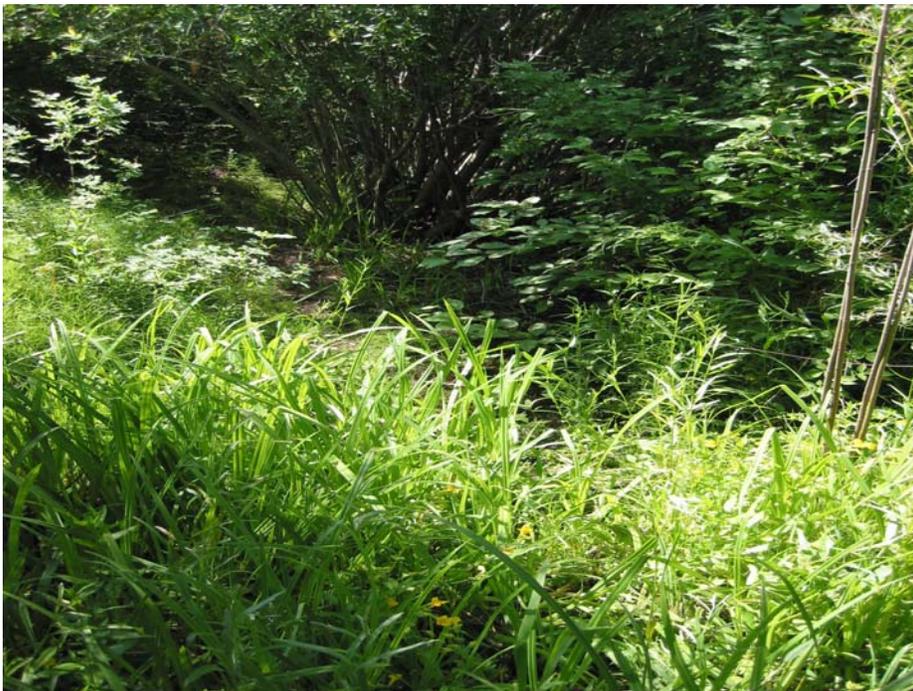
Figure 5. Herbaceous community in Green Riparian Assessment Reach

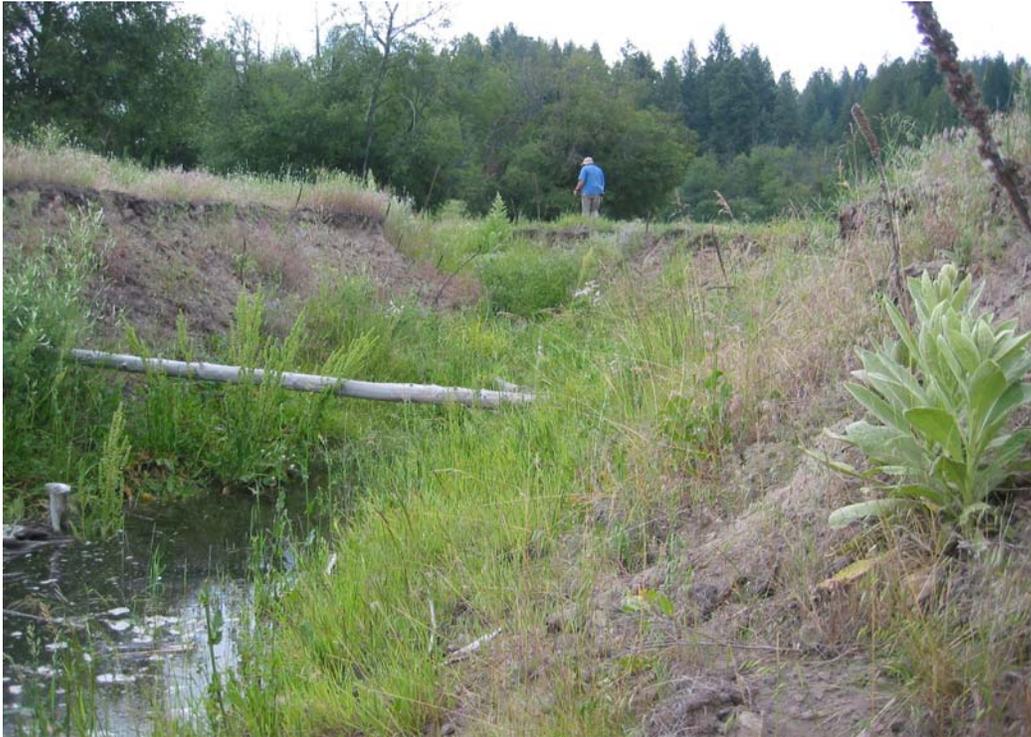
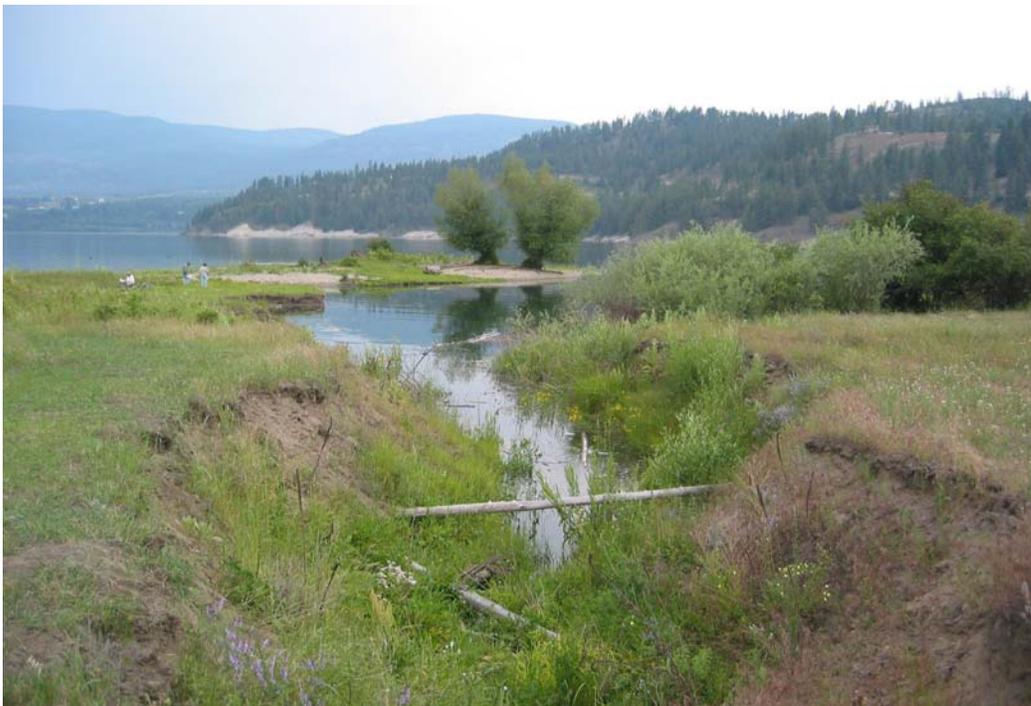
We assessed the lowest portion of this stream, a reach extending 250 feet upstream from the lake shore (Figure 6). The channel is incised approximately 8-10 feet deep near the shoreline (Figures 7a and b), and an active headcut extends approximately 200 feet upstream. In this unstable reach, stream energy is dissipated through channel incision and bank erosion, resulting in a narrow, steep-walled channel with no floodplain. The banks are continuously failing and adding excess sediment to the channel and to the lake. This process appears to be exacerbated by cattle hoof action. If unchecked, the headcut has the potential to degrade much more riparian-wetland habitat upstream and to continue delivering excess sediment to Lake Roosevelt.

Large lake level fluctuations and cattle grazing may have had roles in causing the incision problems observed at this site. When lake stage drops significantly due to dam operations, the hydraulic gradient at the mouth of the stream may

The team rated this stream reach as being in **Nonfunctional** condition due to the obvious vertical and lateral channel instability (headcut, channel incision, and bank failure) and lack of stabilizing riparian-wetland vegetation.

Figure 7a. Incised channel on Eckman allotment (looking upstream)

Figure 7b. Incised channel on Eckman allotment (looking downstream)

Management recommendations: Due to the unstable nature of a headcut in unconsolidated alluvium, it is almost inevitable that this feature will advance further upstream for a considerable distance and destroy additional riparian-wetland habitat. The result will be an incised channel with failing banks that will not support a healthy riparian ecosystem. However, there is still a very good opportunity to stop this process with small-scale structural intervention. We recommend that park staff request assistance from WRD in designing and installing a small diversion structure in the channel above the headcut that would divert flow into a new surface channel toward the south (Figure 8). Back-filling of the incised reach below the structure may also be necessary. This would protect against further loss of riparian-wetland habitat and replace the habitat that has already been lost due to channel incision.

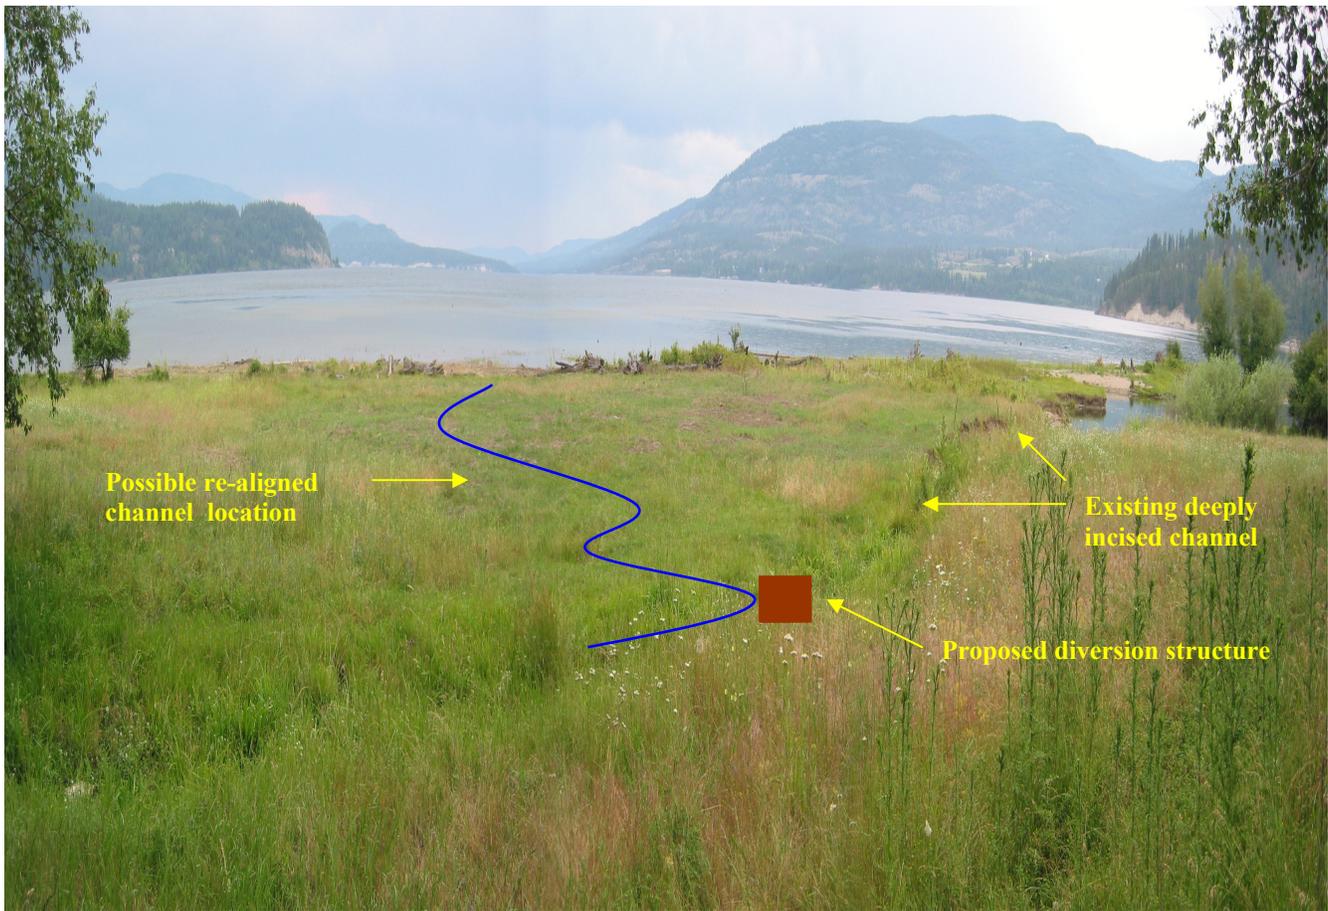
Figure 8. Location of proposed structure to arrest headcut and create new channel on Eckman allotment (exact channel location and dimensions to be determined).

Although herbaceous wetland vegetation should establish in the proposed new channel over time via seeds transported from upstream, we recommend

transplanting locally-derived plugs of rhizomatous rushes, sedges, and other native wetland plant species to jump-start that process and more quickly stabilize the channel. Willow cuttings are also recommended to help stabilize the banks and to improve habitat structure.

We recommend excluding cattle and visitor use from the proposed riparian restoration area for an extended period of time due to the need to let new stabilizing vegetation establish and to help protect the new channel from incision. Establishment of monitoring plots will aid in determining if and when the site is stable enough to withstand pressure from visitors and/or livestock.

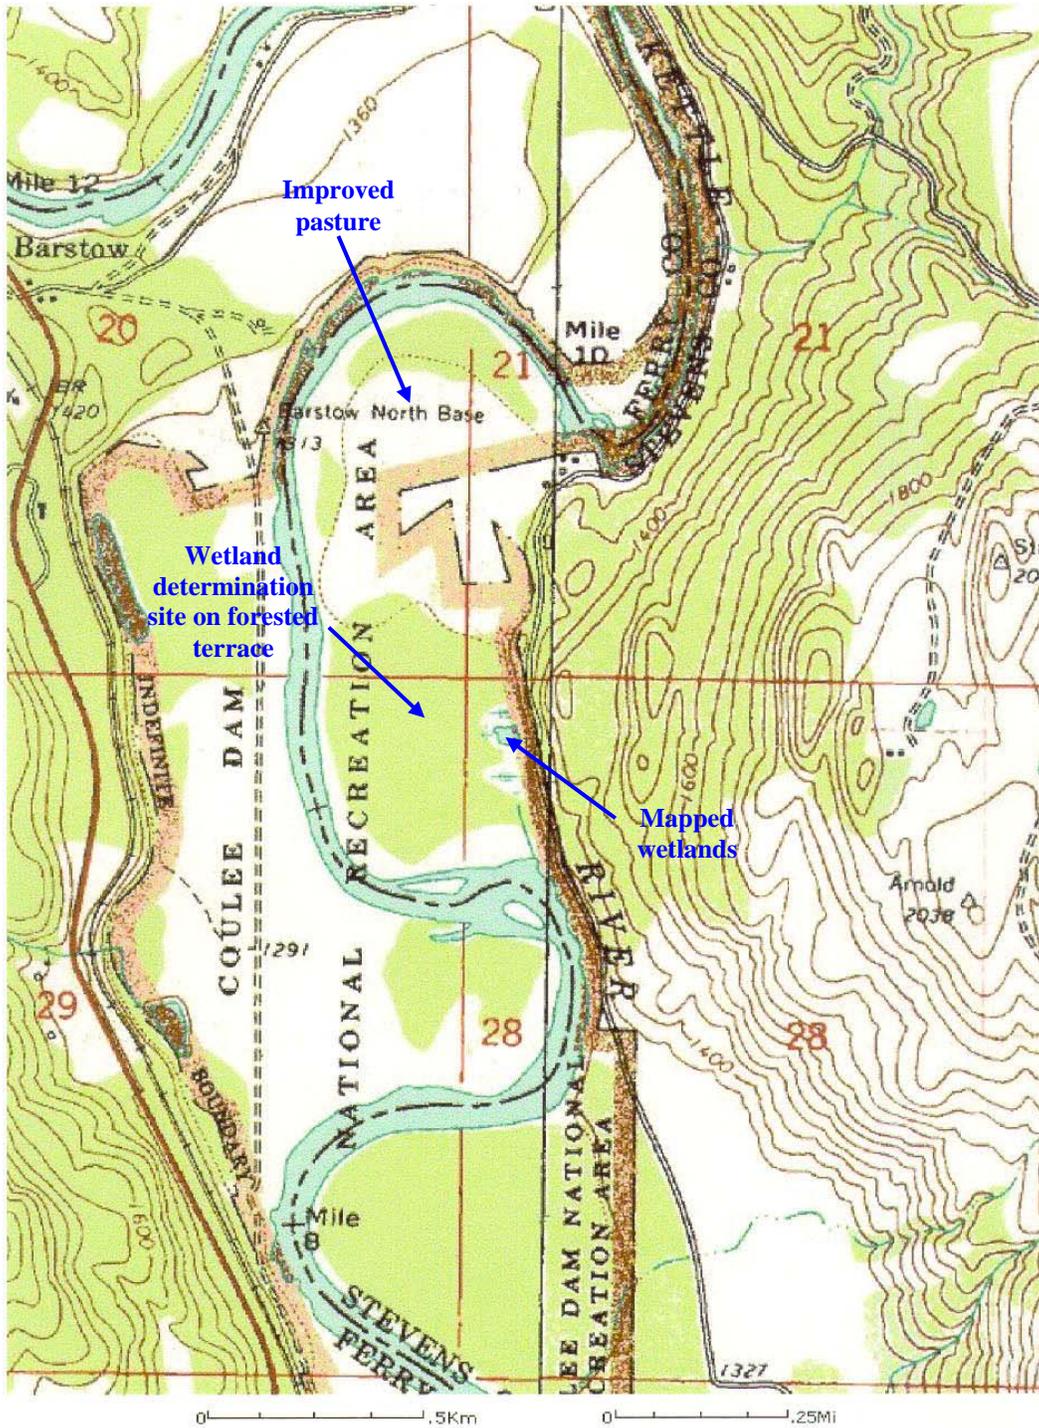
inches. In this relatively wet part of the growing season, we would expect a wetland habitat to have a water table much closer to the surface. None of the primary or secondary hydrologic indicators were observed at this site. Therefore, the hydrology criterion was not met.

Based on failure to meet any of the three required wetland criteria, this site was determined to be an upland environment and, therefore, not subject to NPS, state, or federal wetland policies and regulations. By extension, we determined there are no other wetlands within the forested portion of the allotment.

Figure 9. Location of wetland determination study on Henslee allotment

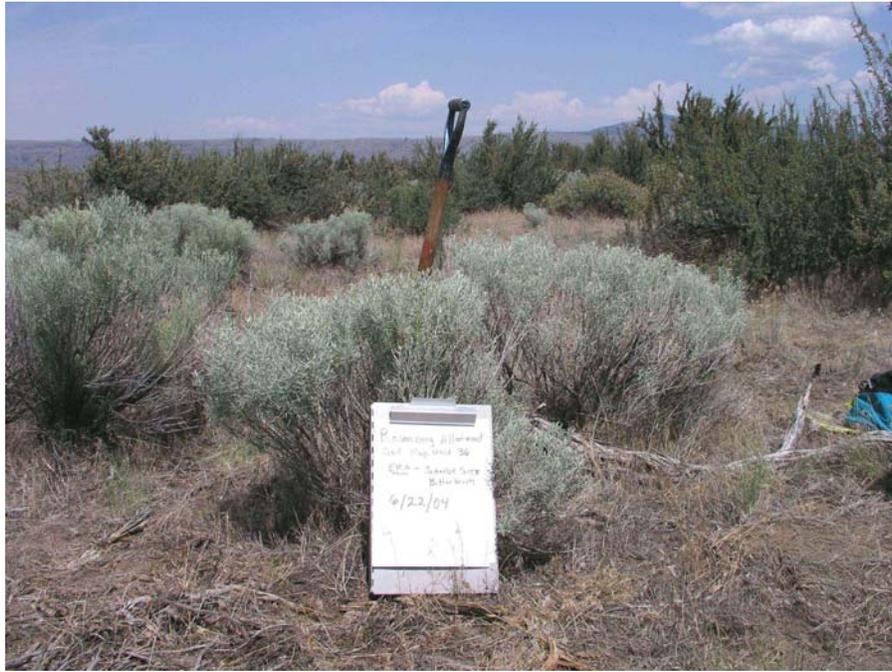
Assessment Results: Using the preponderance of evidence approach, the team noted a *none to slight* departure from the Soil/Site Stability attribute, a *none to slight* departure from the Hydrologic Function attribute, and a *slight to moderate* departure from the Biotic Integrity attribute, mainly due to the presence of invasive plant species on the site, and a slight decline in functional groups expected for the site.

Figure 10. Rosenberg allotment rangeland assessment site

Management recommendations: Current livestock management appears to be compatible with the Indicators of Rangeland Health. However, there is a risk that livestock use of perennial grasses may enhance the dominance of annual grasses. We recommend that the timing and intensity of grazing be managed to minimize impacts to perennial grasses, particularly bluebunch wheatgrass, which is susceptible to grazing early in its growth. We recommend grazing after the fall regrowth has occurred and before growth begins in the spring or late summer/early fall.

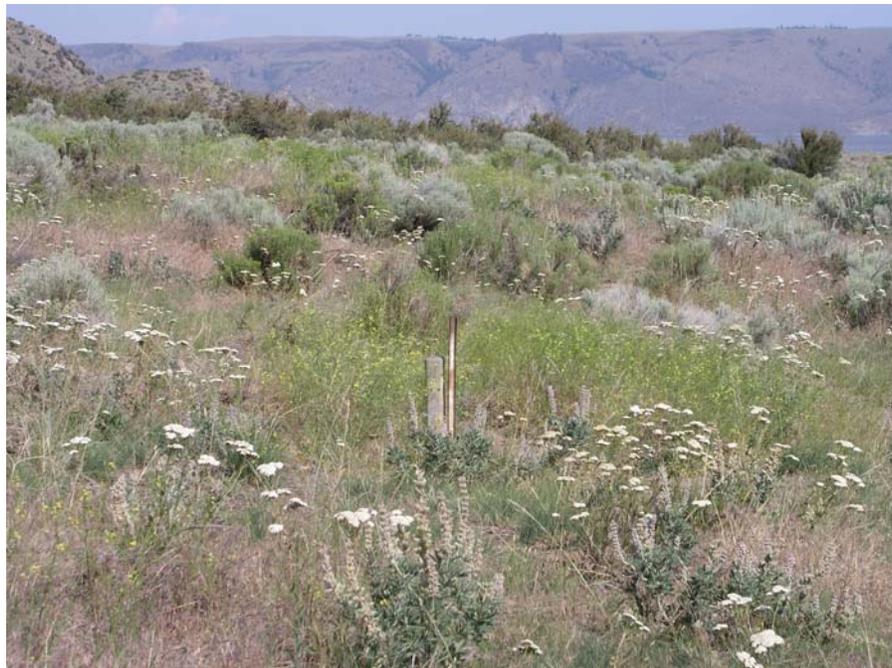
Assessment Results: Using the preponderance of evidence approach, the team noted a *none to slight* departure from the Soil/Site Stability attribute, a *none to slight* departure from the Hydrologic Function attribute, and a *moderate* departure from the Biotic Integrity attribute, mainly due to the presence of invasive plant species on the site, and a moderate decline in functional groups expected for the sight.

Figure 11. Green allotment rangeland assessment, site 1

Management recommendations: Current livestock management appears to be compatible with the Indicators of Rangeland Health, but care should be taken to monitor trends within the functional groups of the same, as well as the spatial distribution of invasive plants in the area. However, please see concerns regarding perennial grasses in the “Management recommendations” section for the Rosenberg Allotment.

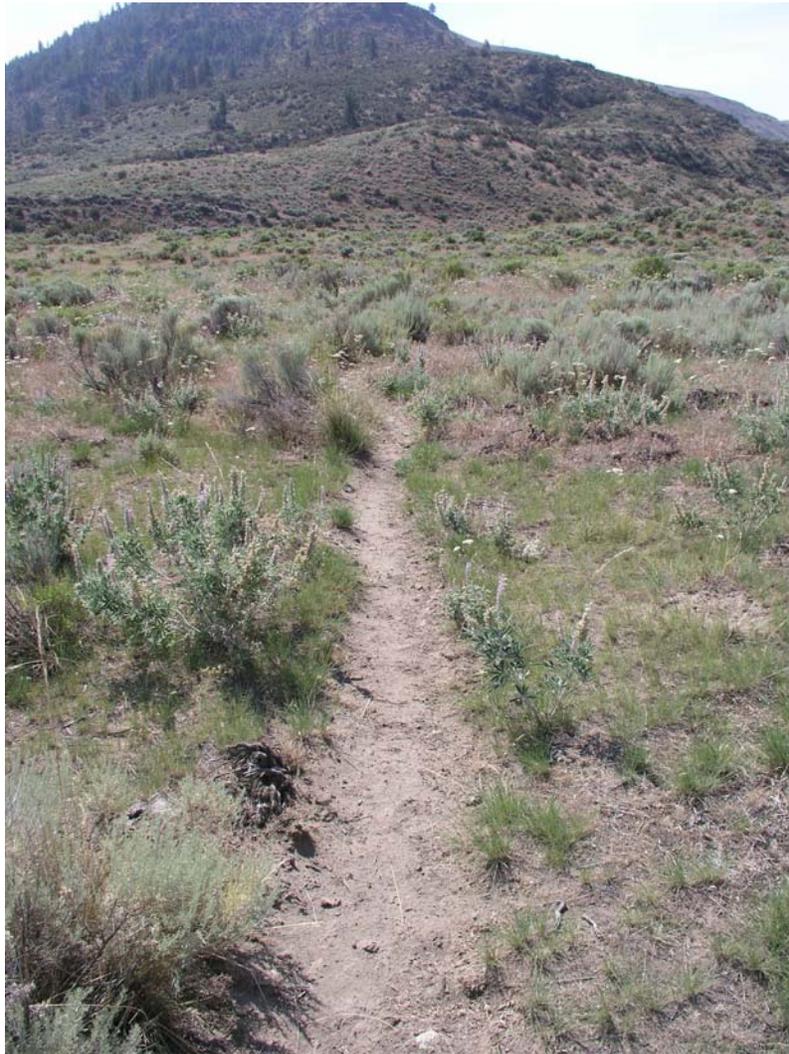
Very little evidence of erosion by water or wind was present, and the amount of plant litter and bare ground was within the range expected for the site. Bare ground was noted predominantly in the areas between shrub canopies. The presence and distribution of biological soil crusts was also within the range expected for the site. Livestock trails in the area did not display any downcutting from water erosion, and adjacent plants did not display any coppice dunes from wind erosion off these trails (Figure 12).

Figure 12. Livestock trail with minimal signs of accelerated water or wind erosion on Green allotment, site 1

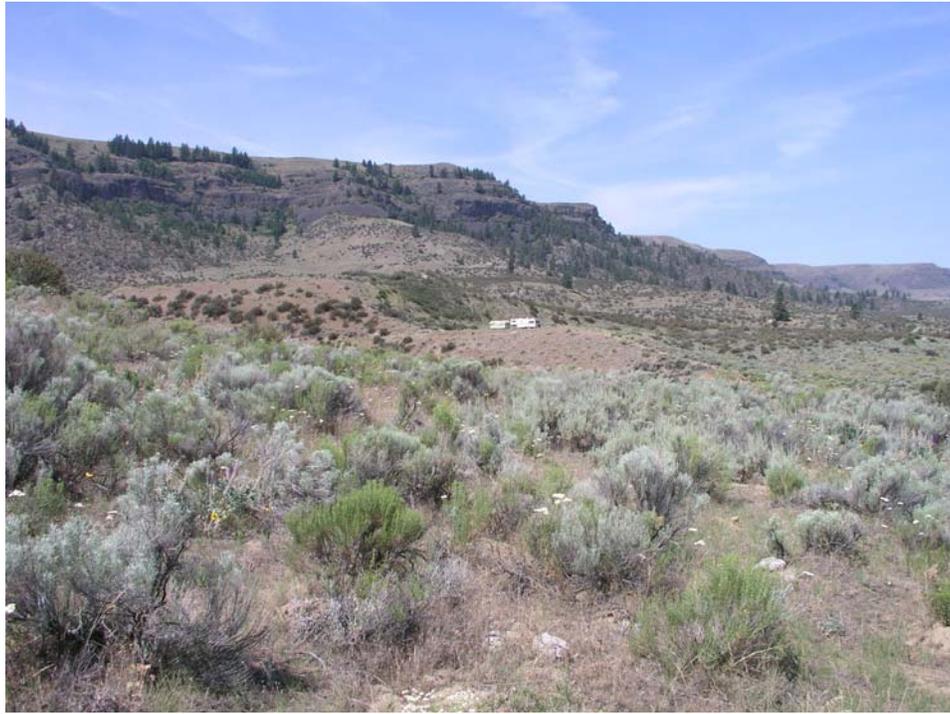
Assessment Results: Using the preponderance of evidence approach, the team noted a *none to slight* departure from the Soil/Site Stability attribute, a *none to slight* departure from the Hydrologic Function attribute, and a *slight to moderate* departure from the Biotic Integrity attribute, mainly due to the presence of invasive plant species on the site, and a decline in functional groups expected for the sight.

Figure 13. Green allotment rangeland assessment site 2

Management recommendations: Current livestock management appears to be compatible with the Indicators of Rangeland Health. However, please see concerns regarding perennial grasses in the “Management recommendations” section for the Rosenberg Allotment.

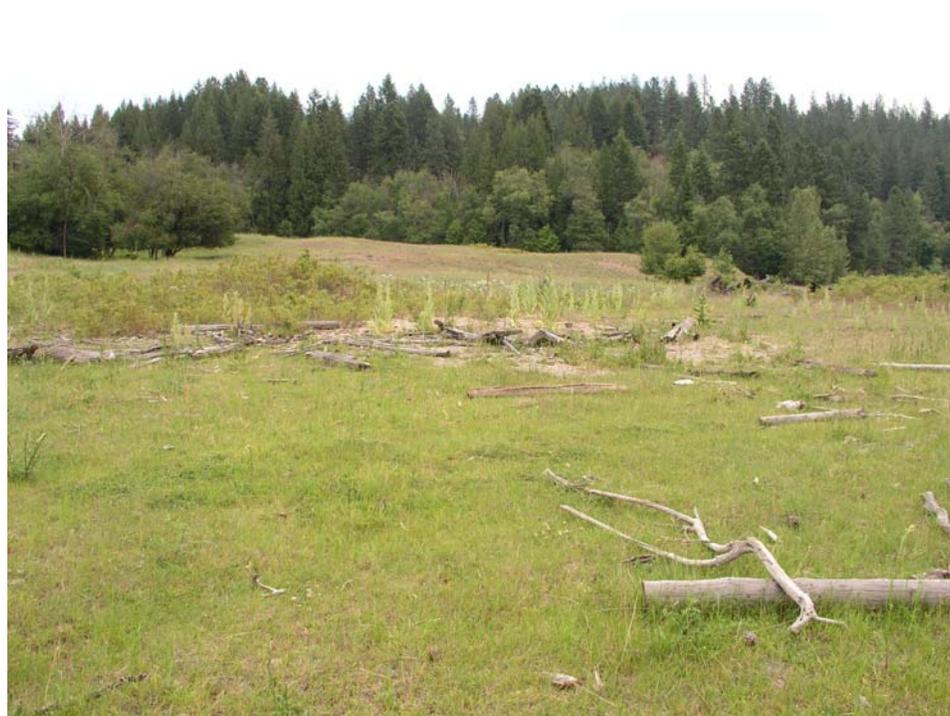
Assessment Results: Using the preponderance of evidence approach, the group noted a *moderate* departure from the Soil/Site Stability attribute, a *moderate* departure from the Hydrologic Function attribute, and *moderate* departure from the Biotic Integrity attribute. These results are mainly due to the amount of disturbance at the site (from both livestock and recreational use), as well as the presence of invasive and non-native plant species on the site.

Figure 14. Eckman allotment rangeland assessment site

Management recommendations: We recommend excluding cattle and visitor use from both the adjacent area of proposed stream channel restoration and this area of evaluation for an extended period of time. Active management of weeds may be necessary as they are well established. In addition, the establishment of monitoring plots will aid in determining if and when the site is stable enough to withstand pressure from visitors and/or livestock.
