Status, Evolution, and Storm Vulnerability Assessments of the Shoreline at George Washington Birthplace National Monument

Technical Report

C. Scott Hardaway, Jr., Donna A. Milligan, Kevin P. O'Brien, and Christine A. Wilcox

May 2009 (Revised October 2009)

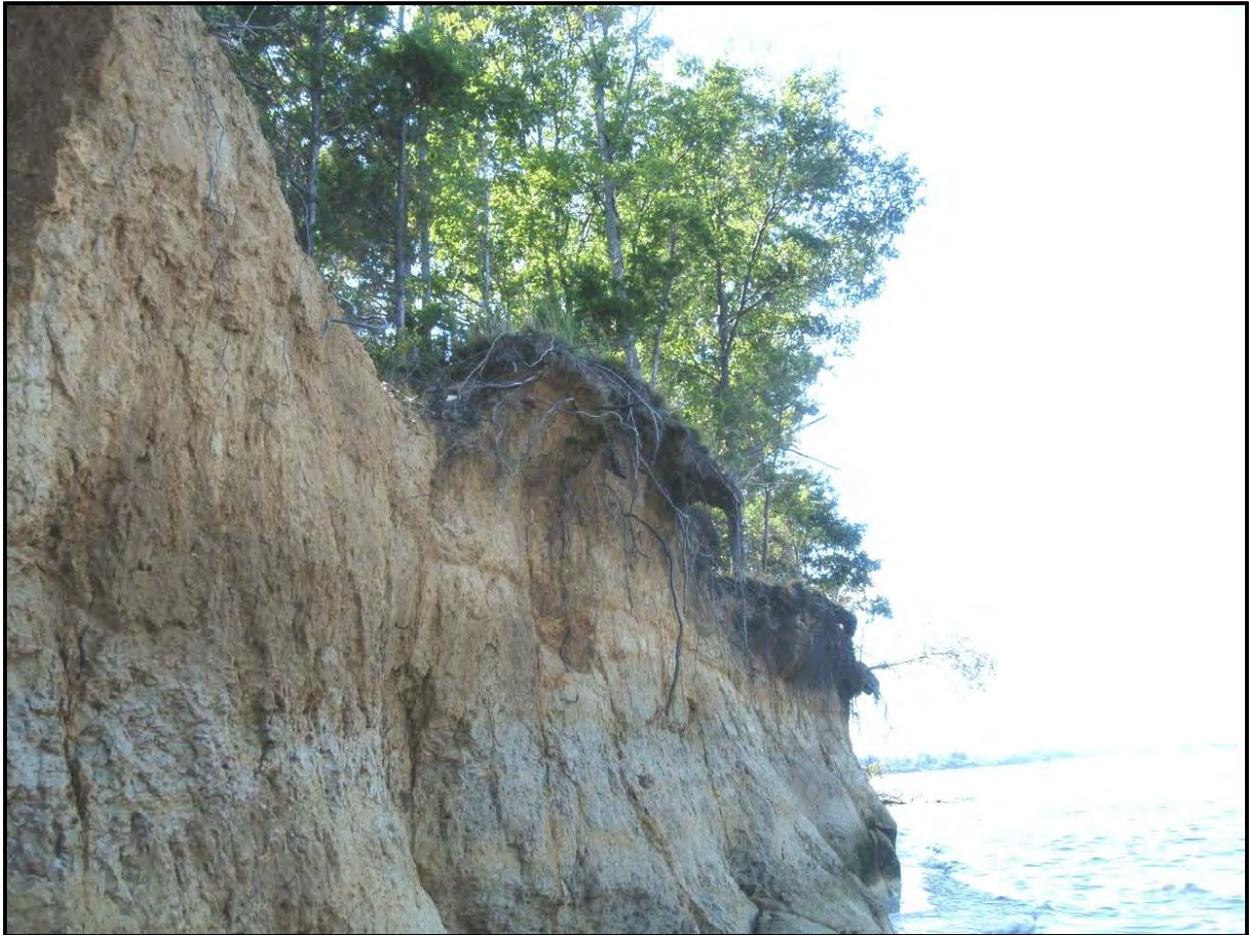
ON THE COVER

Eroding high banks along the Potomac River at the George Washington Birthplace National Monument on 18 September 2008.
Photography by: Shoreline Studies Program, Virginia Institute of Marine Science.

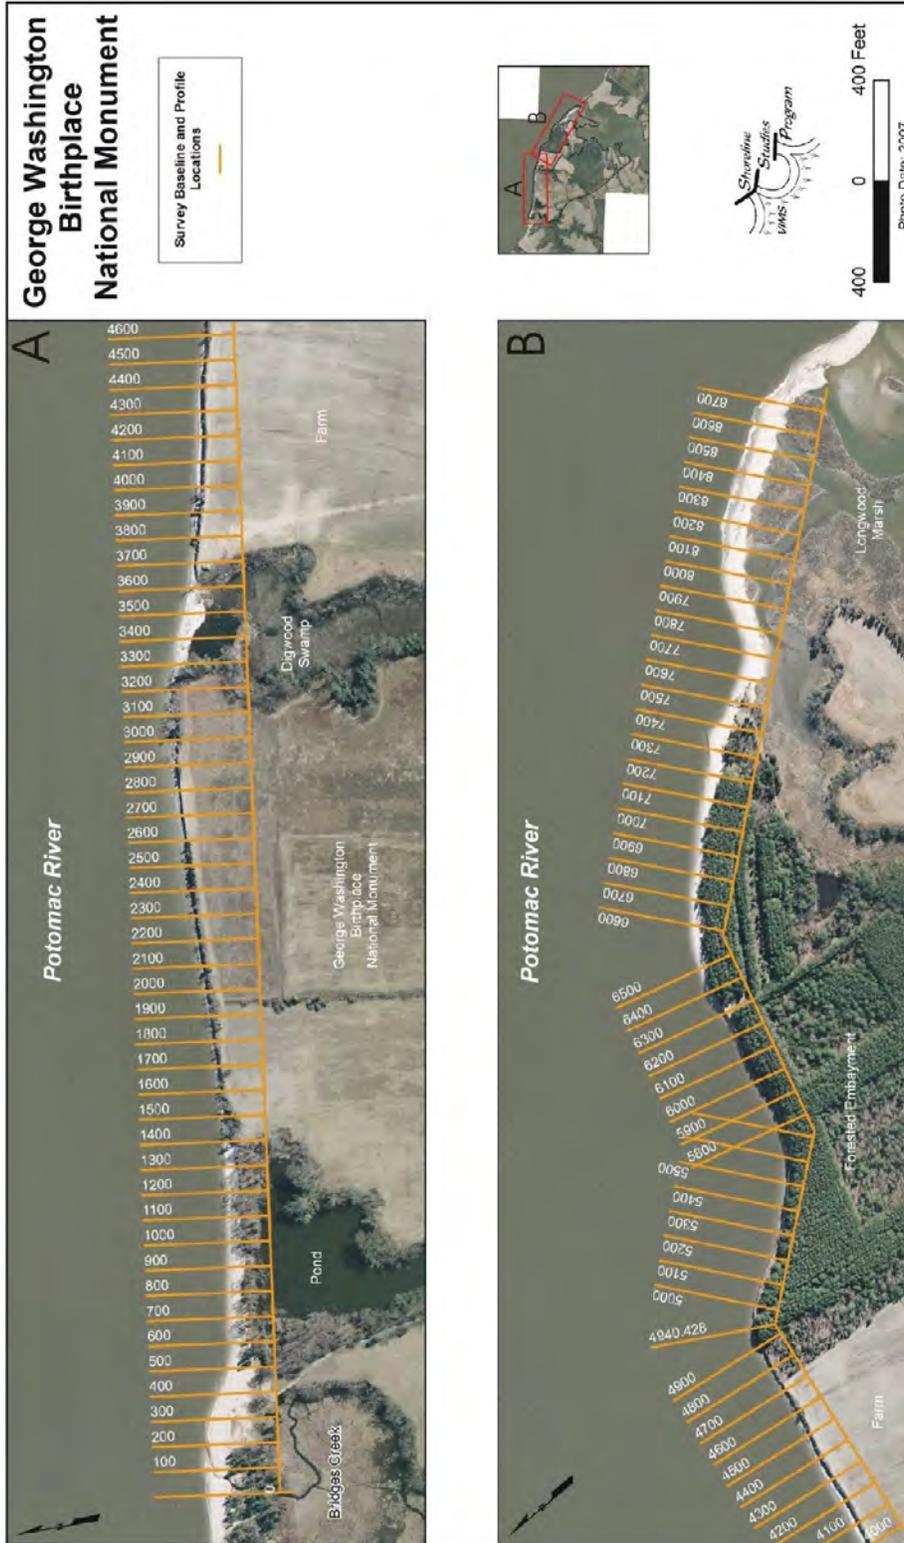
Figure 4. Location of profile cross-sections along the Potomac River coast.

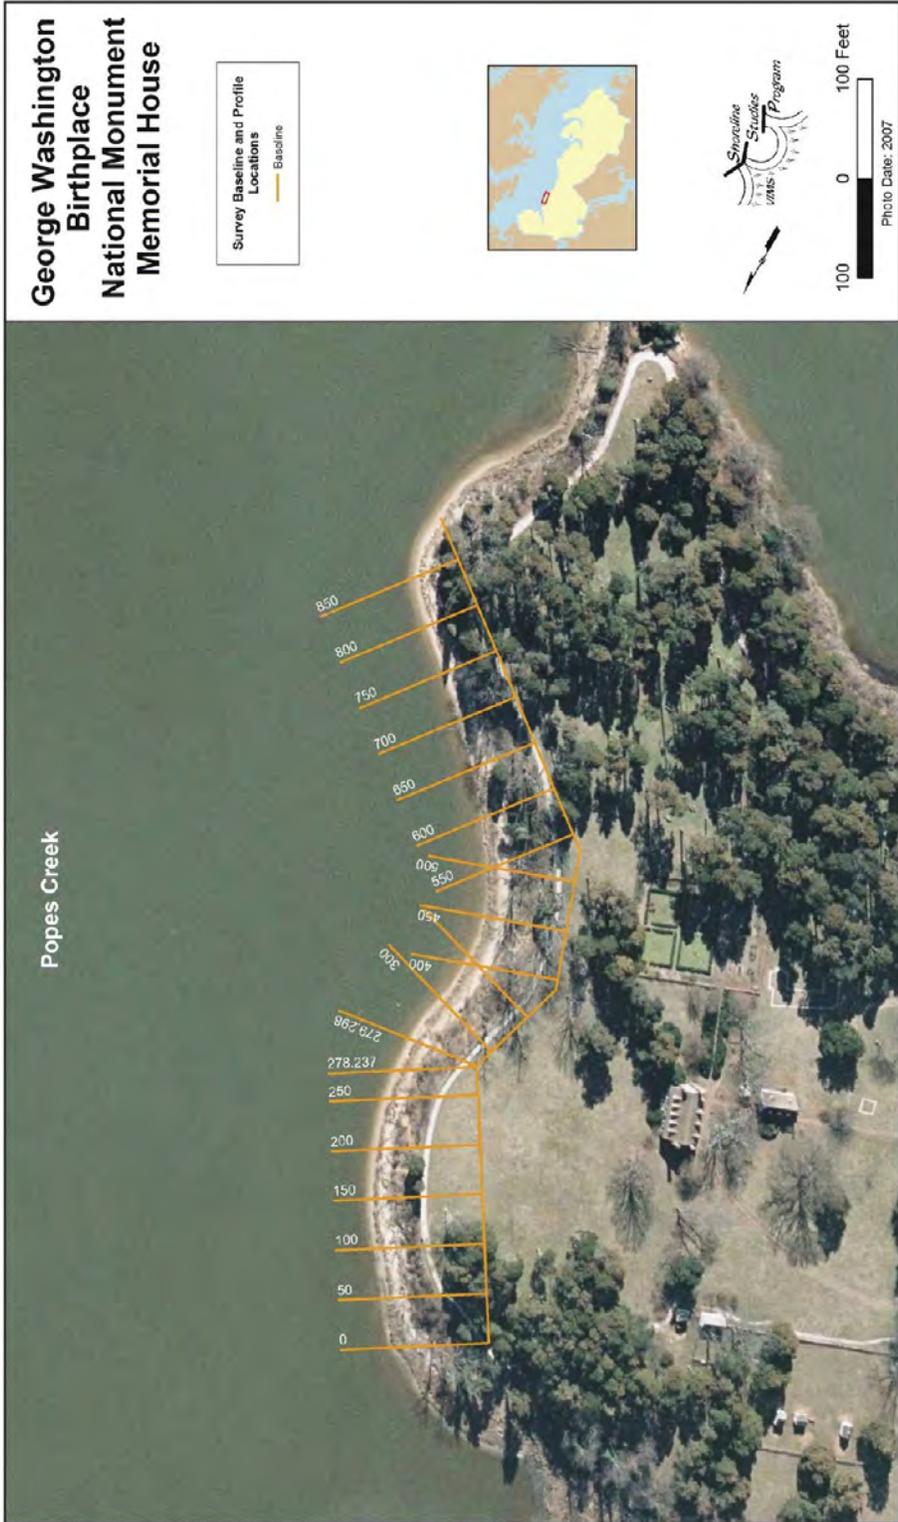
Figure 5. Location of profile cross-sections along Popes Creek.

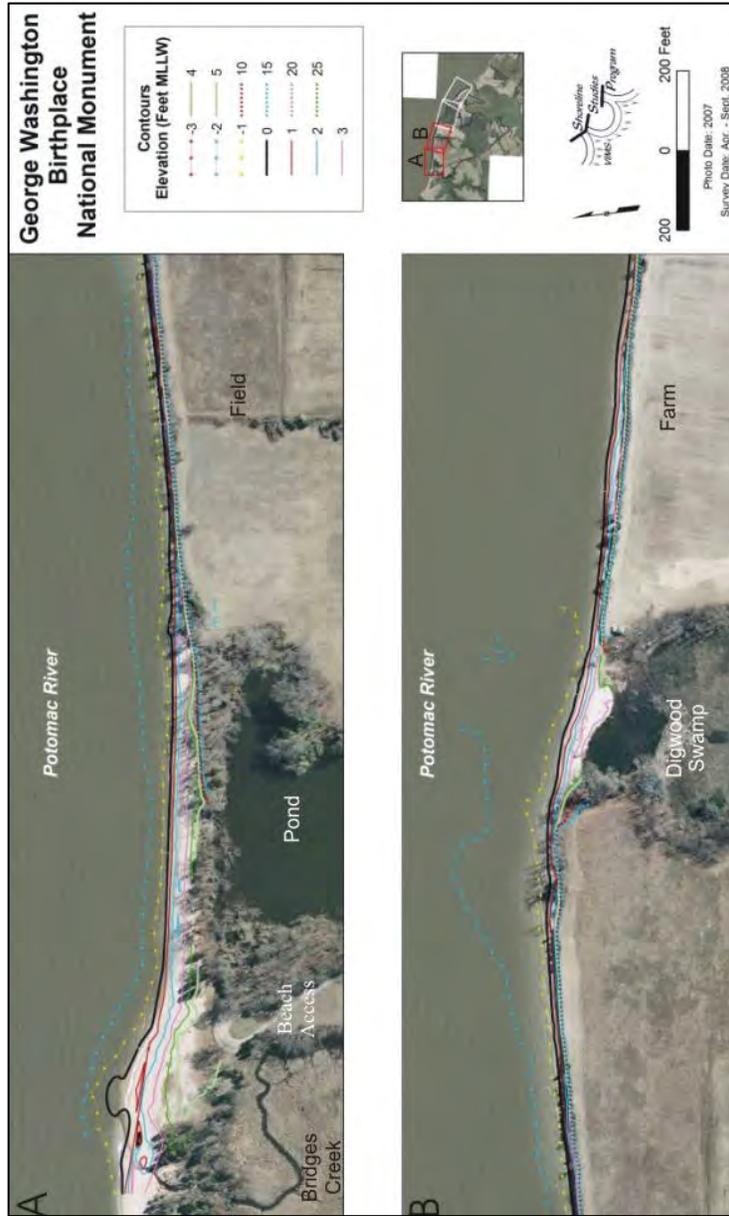
Figure 20. RTK-GPS elevation contours along GEWA's western Potomac River shoreline.

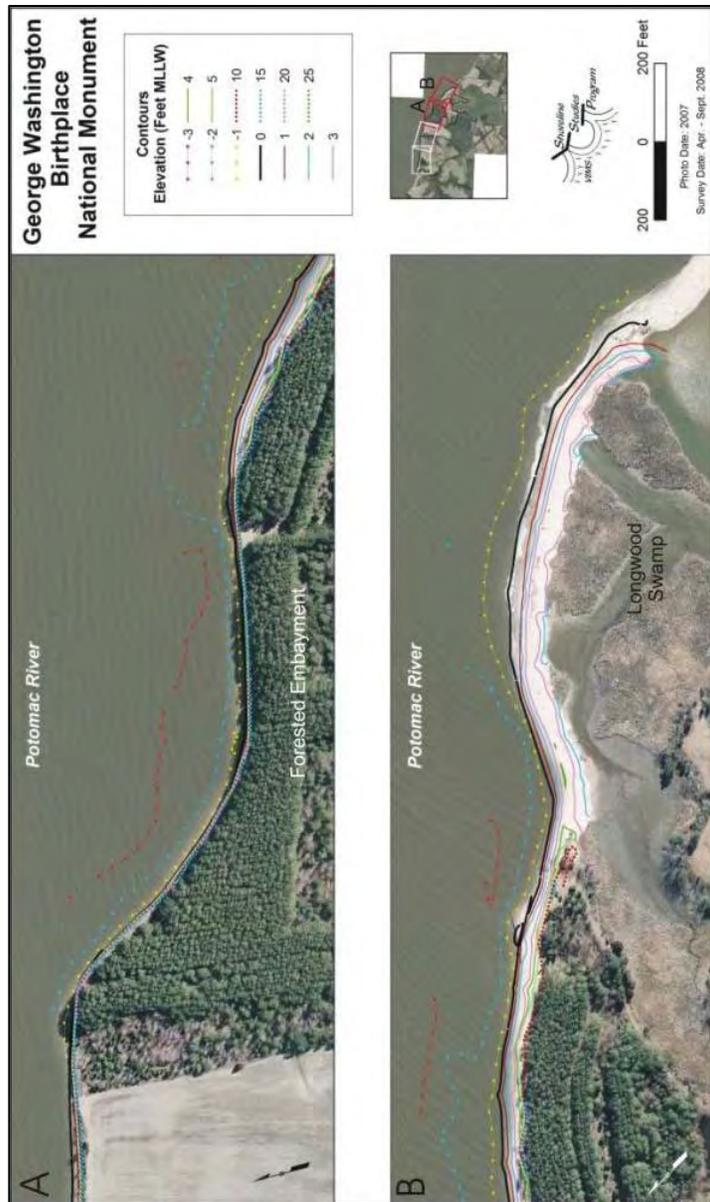
Figure 21. RTK-GPS elevation contours along GEWA's eastern Potomac River shoreline.

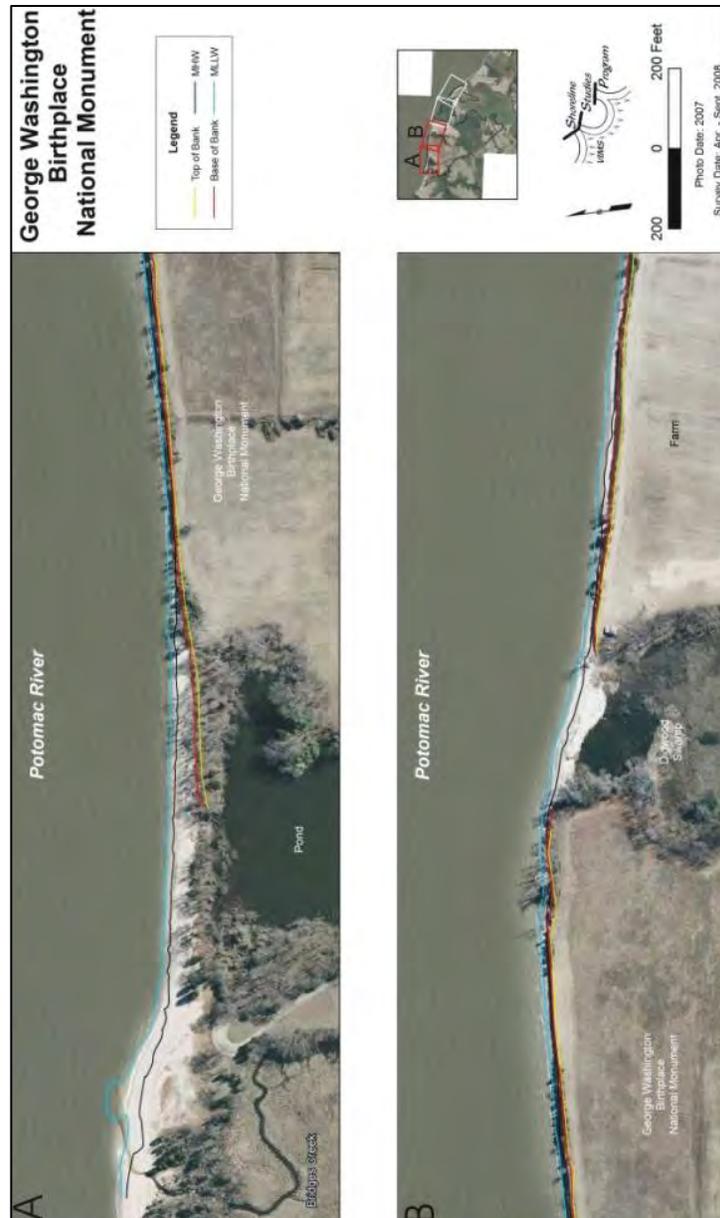
Figure 22. RTK-GPS survey results showing the top of bank, base of bank, mean high water, and mean lower low water along GEWA's western Potomac River shoreline.

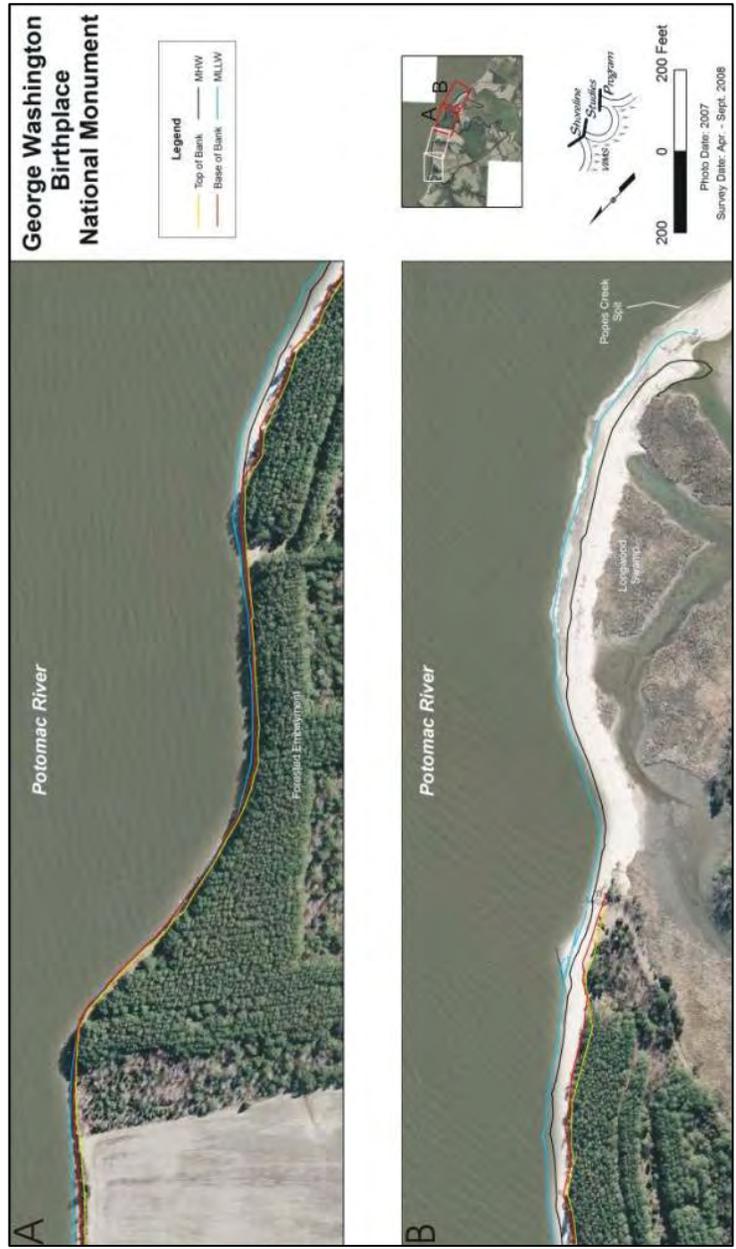
Figure 23. RTK-GPS survey results showing the top of bank, base of bank, mean high water, and mean lower low water along GEWA's eastern Potomac River shoreline.

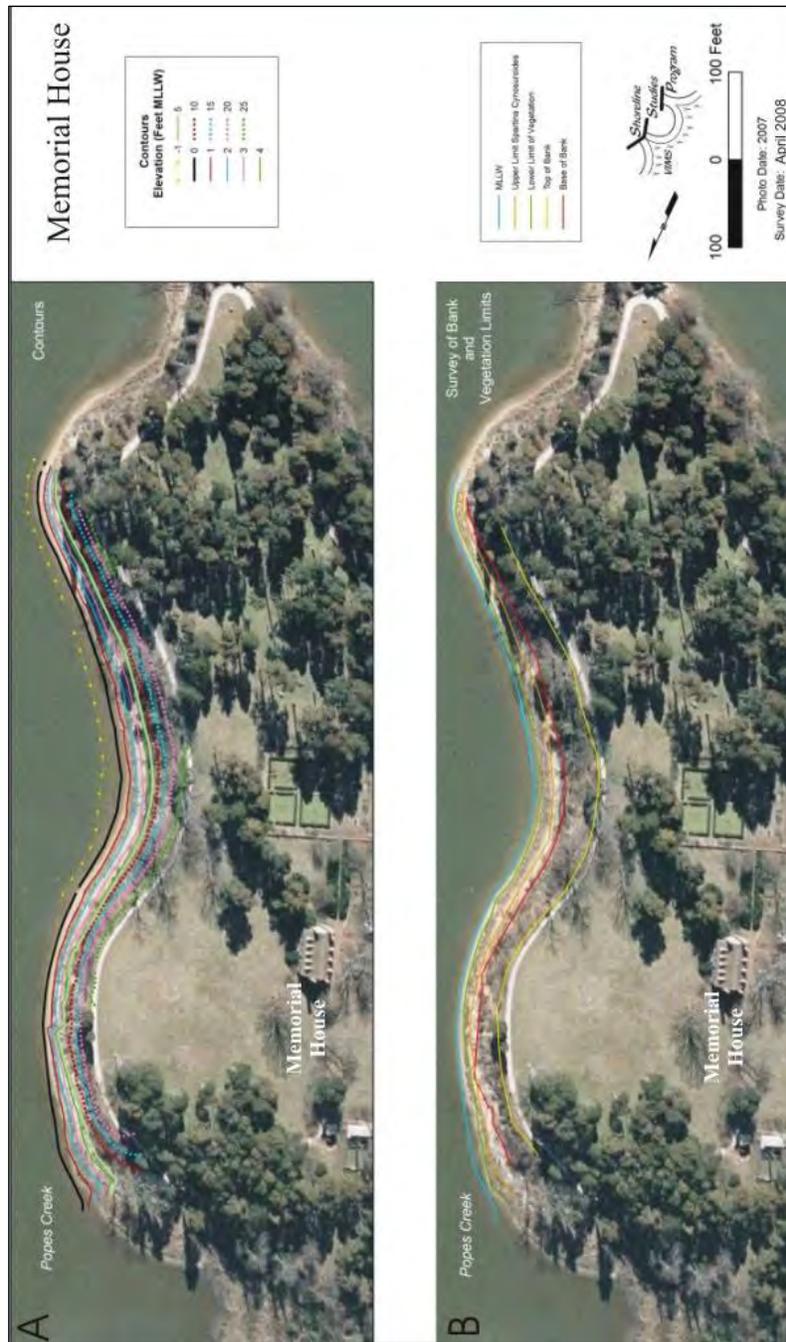
Figure 25. Survey results along GEWA's Popes Creek shoreline at the Memorial House showing (A) elevation contours and (B) topographic and vegetative features.

Figure 25A presents the surveyed elevations and Figure 25B the locations of the tops and base of the bank and tidal datums along Popes Creek in front of Memorial House. The shore along Popes Creek is not nearly as steep as along the Potomac and has a vegetative marsh fringe (Appendix A, photos 25–28). The elevations immediately inland are higher (maximum 8.2 m [27 ft] MLLW) than along the Potomac.

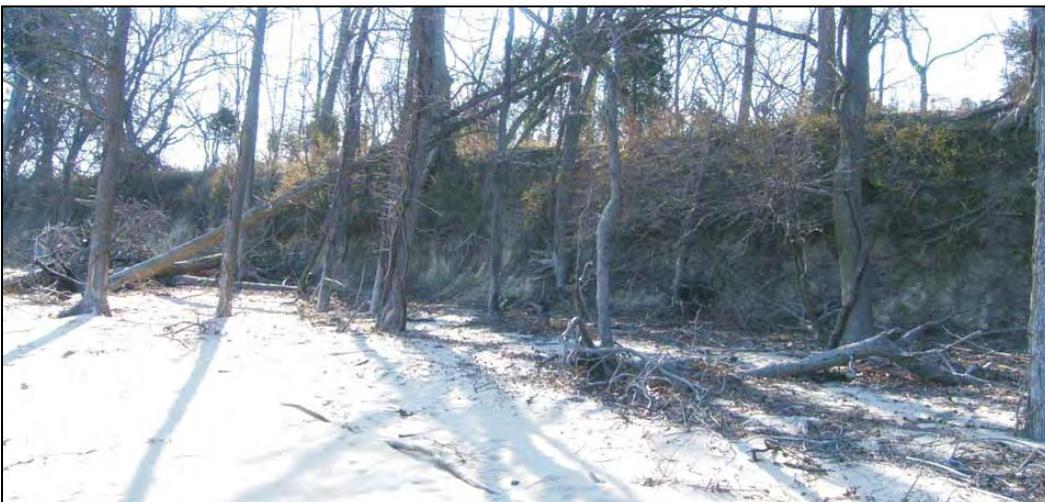
Figure A5. Bank erosion in front of the pond.

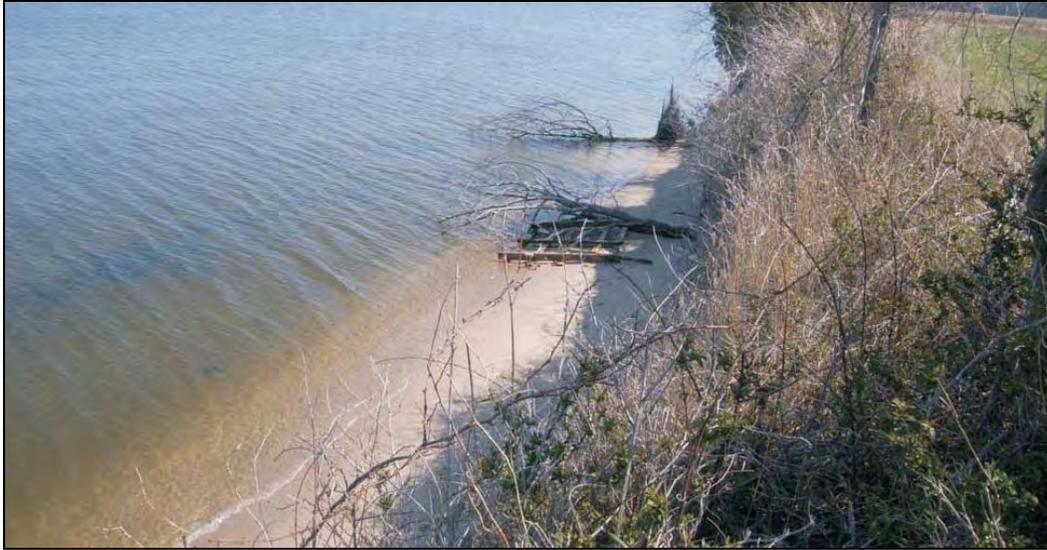
Figure A6. Eroding shoreline at the field.

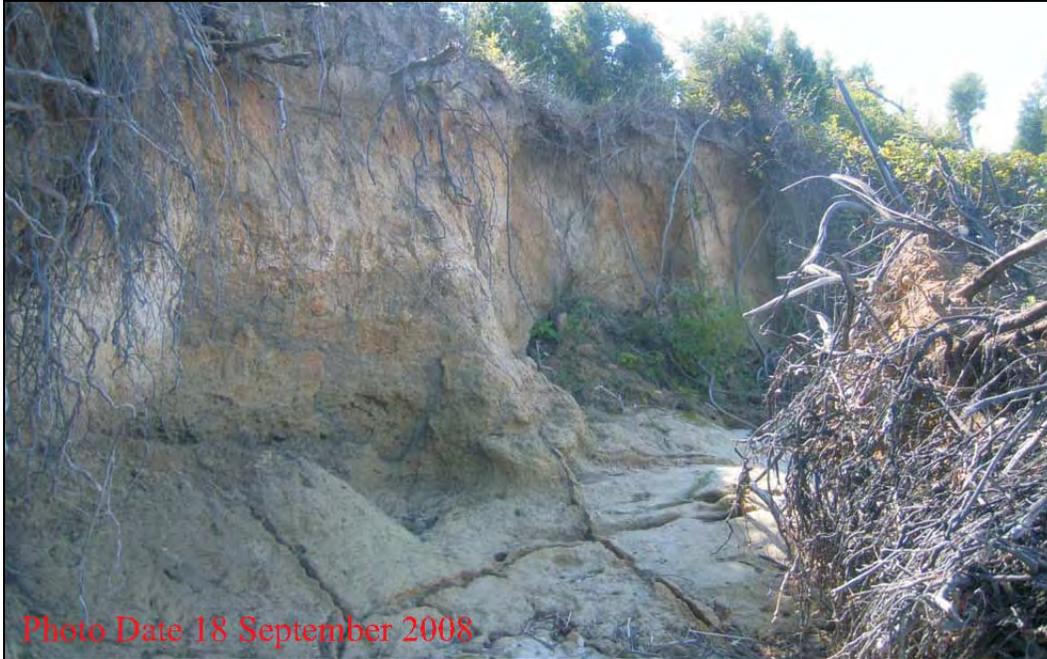
Figure A9. Erosional headland west of Digwood Swamp.

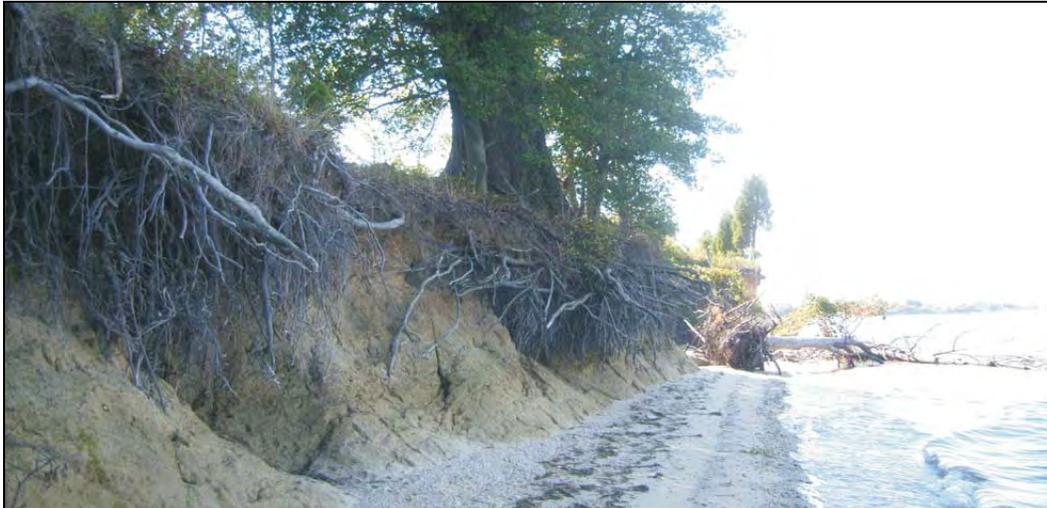
Figure A10. Erosional headland west of Digwood Swamp.

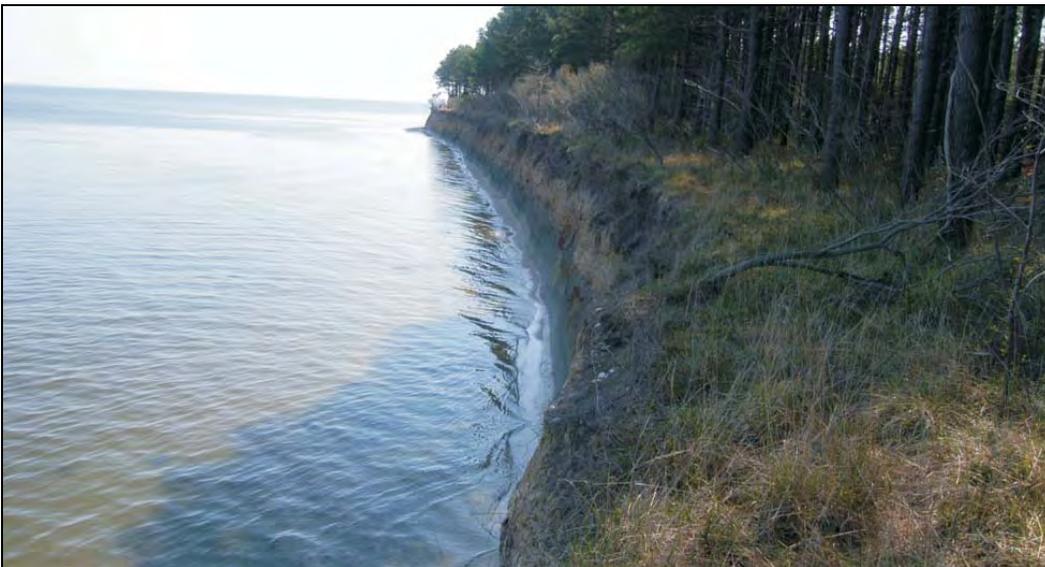
Figure A14. Vertical banks with no beach at high water in forested embayment.

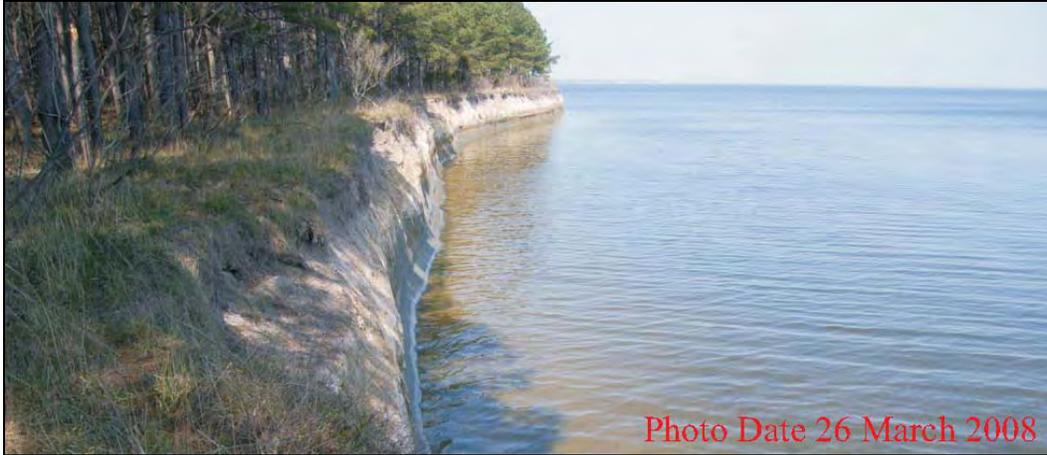
Figure A15. Vertical banks with no beach at high water along forested embayment -Top of bank elevation varies due to erosion at the top.

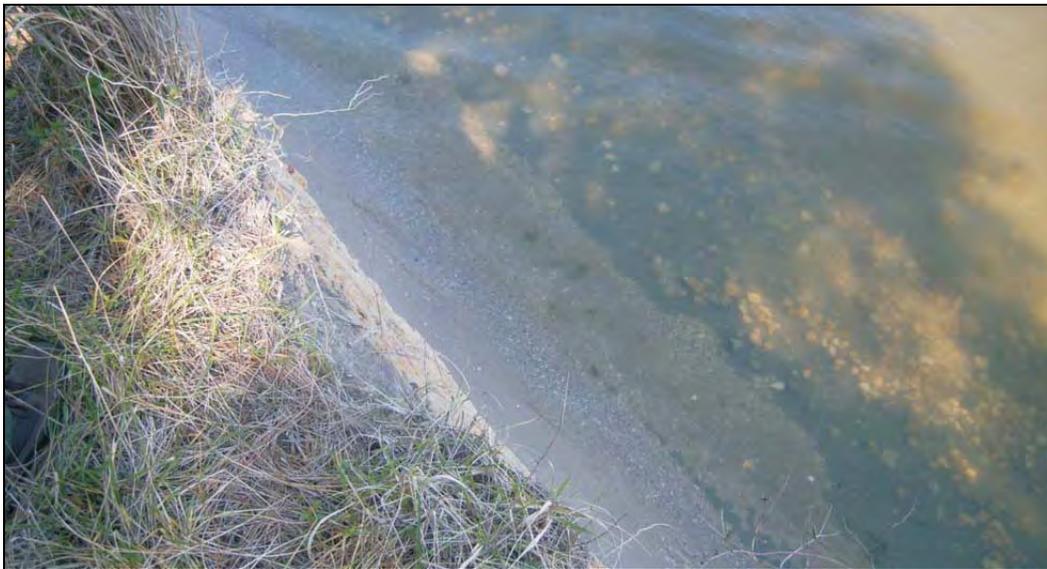
Figure A16. Vertical bank face.

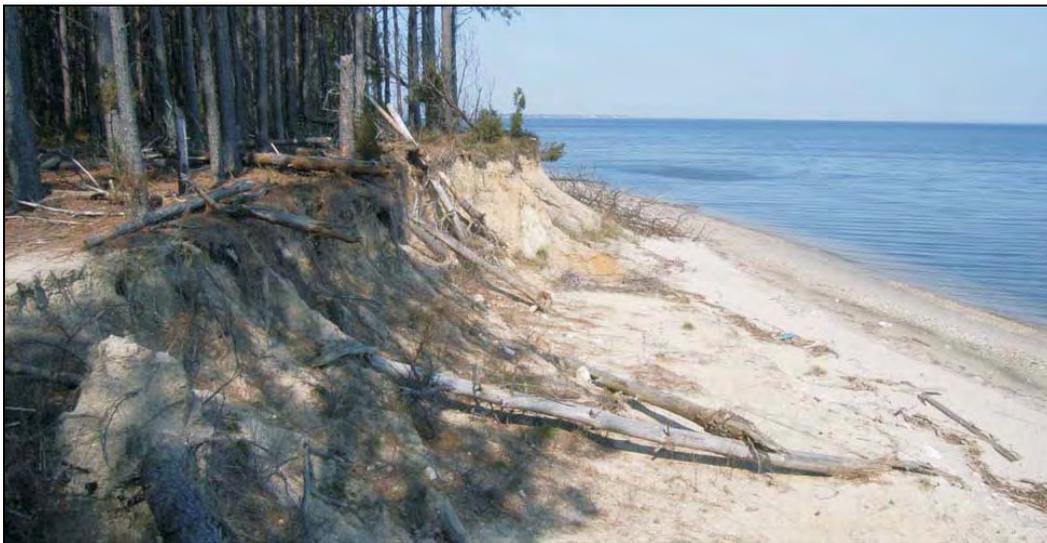
Figure A18. Eroding banks along the northeast facing shoreline.

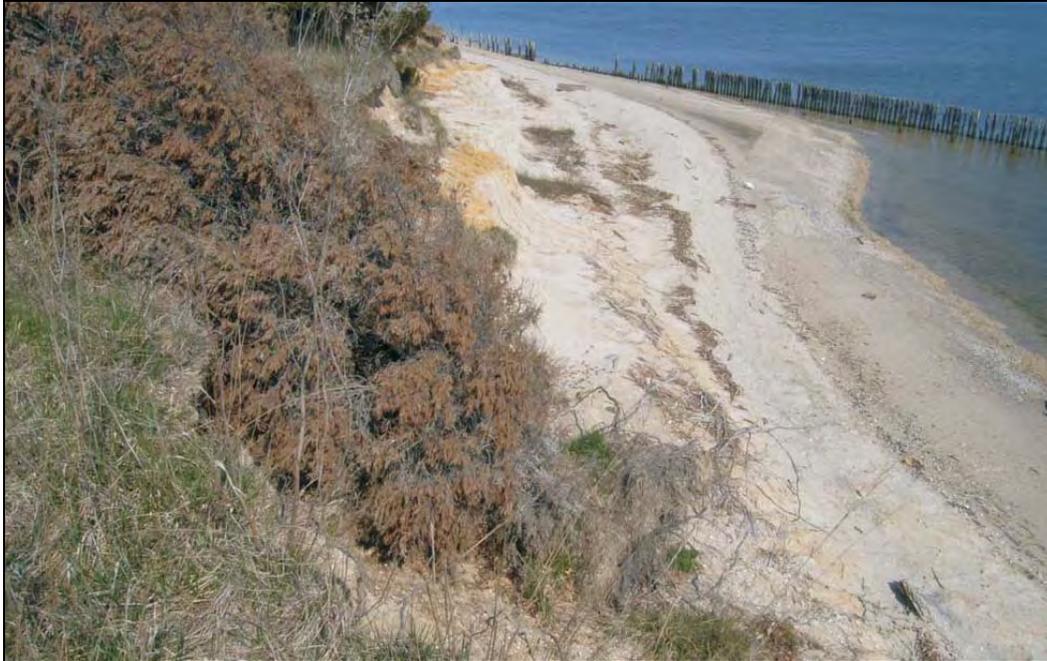
Figure A19. Along the northeast facing shoreline north of the sandy spit -Remnants of an old bulkhead are evident.

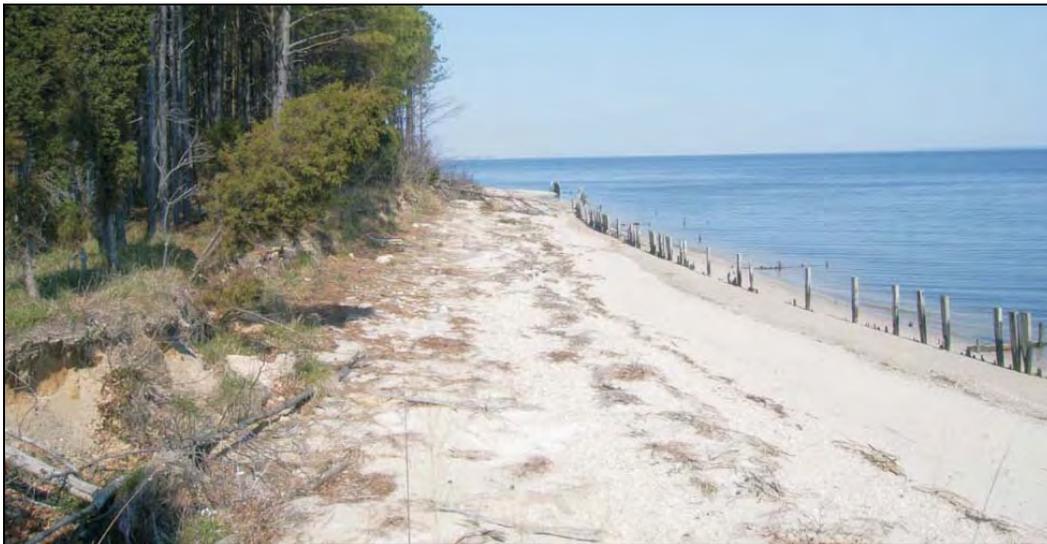
Figure A20. Shoreline where the sandy spit that fronts Longwood Swamp attaches to the upland - Remnants of an old bulkhead are evident.

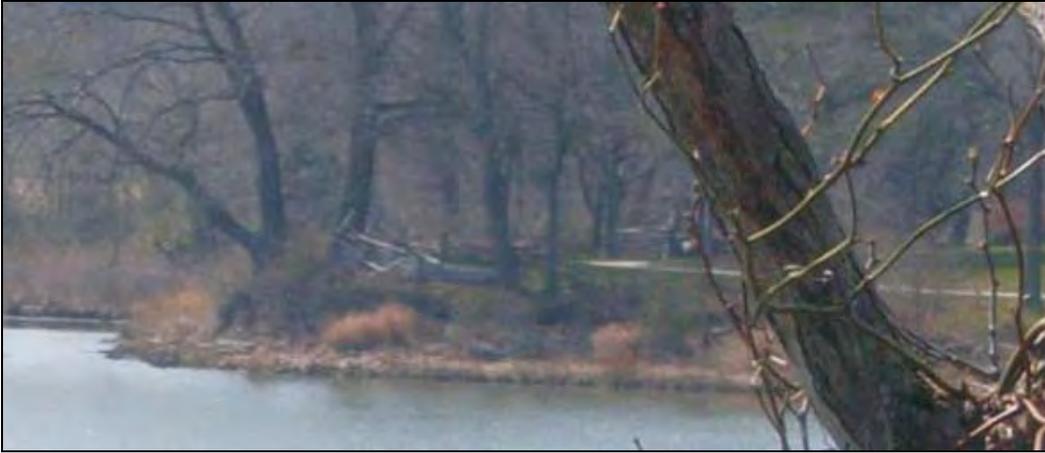
Figure A30. Eroding point of land near the Visitor's Center.

While not directly part of this study, shore erosion is occurring at the Visitor Center which is placed close to the shore. In addition, the height of the bank is lower in this region. For these reasons, it was considered vulnerable (Figure 32). Overall, about 1,200 m (3,800 ft) of shoreline was rated as “most vulnerable” and 300 m (1,000 ft) was rated as “vulnerable” along Potomac River and Popes Creek.
