# Summary of Spring Flow Decline and Local Hydrogeologic Studies, 1969-2007

## *Pipe Spring National Monument*

Natural Resource Report NPS/NRPC/WRD/NRTR—2007/365

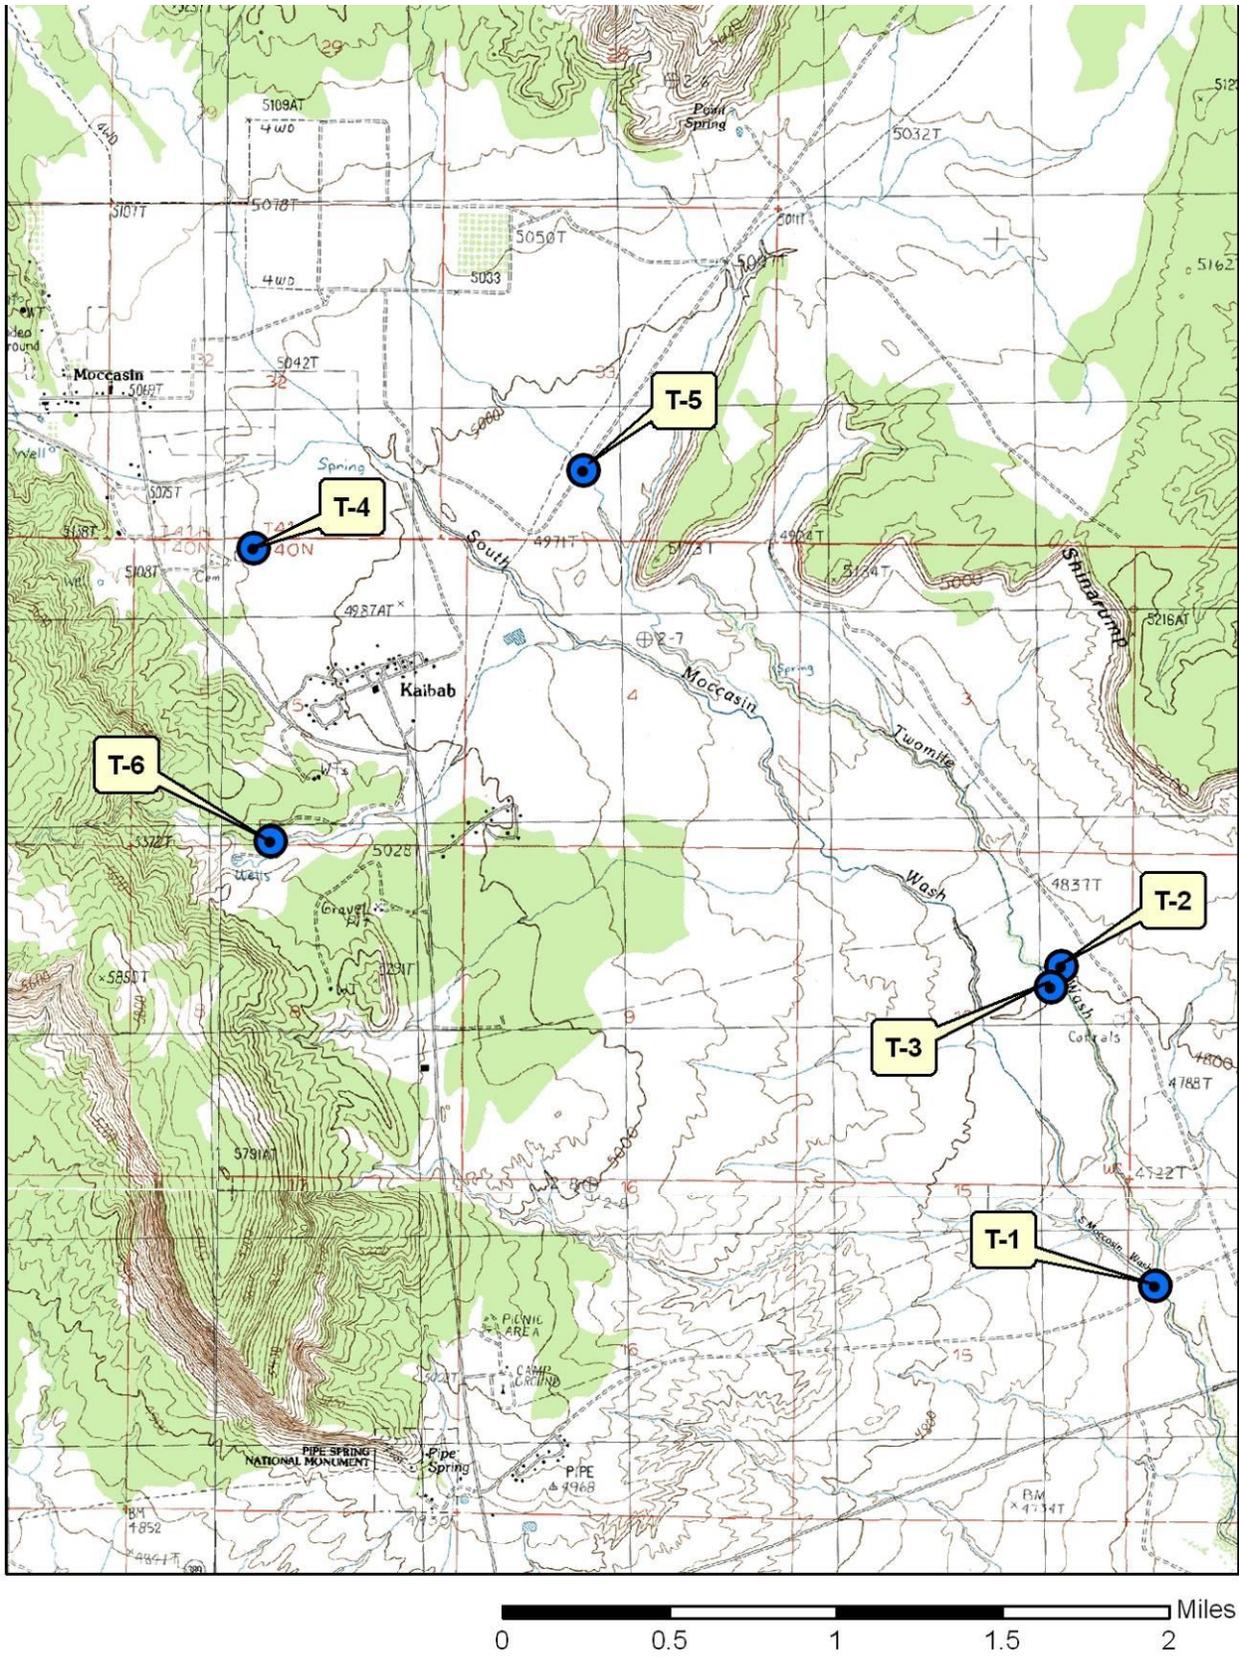
Figure 1. Location of NPS test wells drilled in 1971.

In the spring of 1971 the USGS, under the direction of the Park Service drilled 5 test wells in the alluvium along Twomile and South Moccasin Washes (Figure 1). These test wells were either dry or produced poor-quality water (McGavock, 1974). A sixth test well was then constructed to test the Navajo Sandstone along the Sevier Fault. This well (T-6, aka NPS Well) produced abundant water and was completed as the water supply well for the monument. It has been the

Test wells 4 and 5 (Figure 1) penetrated 44 and 120 feet of alluvium along Moccasin Wash and were dry.

Test Well 6 (Figure 1) was located to test the water-yielding potential of the Navajo Sandstone where it has been fractured by the Sevier Fault. The well was drilled to 205 feet and produced

McGavock offered the opinion that, “The possibility of diminishing the flow of Pipe Spring at the monument by pumping 150 gpm from Test Well 6 is believed to be negligible owing to the 2-mile distance between the well site and Pipe Spring and the fact that the water is under unconfined conditions.” [While this statement is true for short-term propagation of impacts to spring flow, it has no bearing on the long-term effect of groundwater pumping on the water budget and decline of spring flow.]

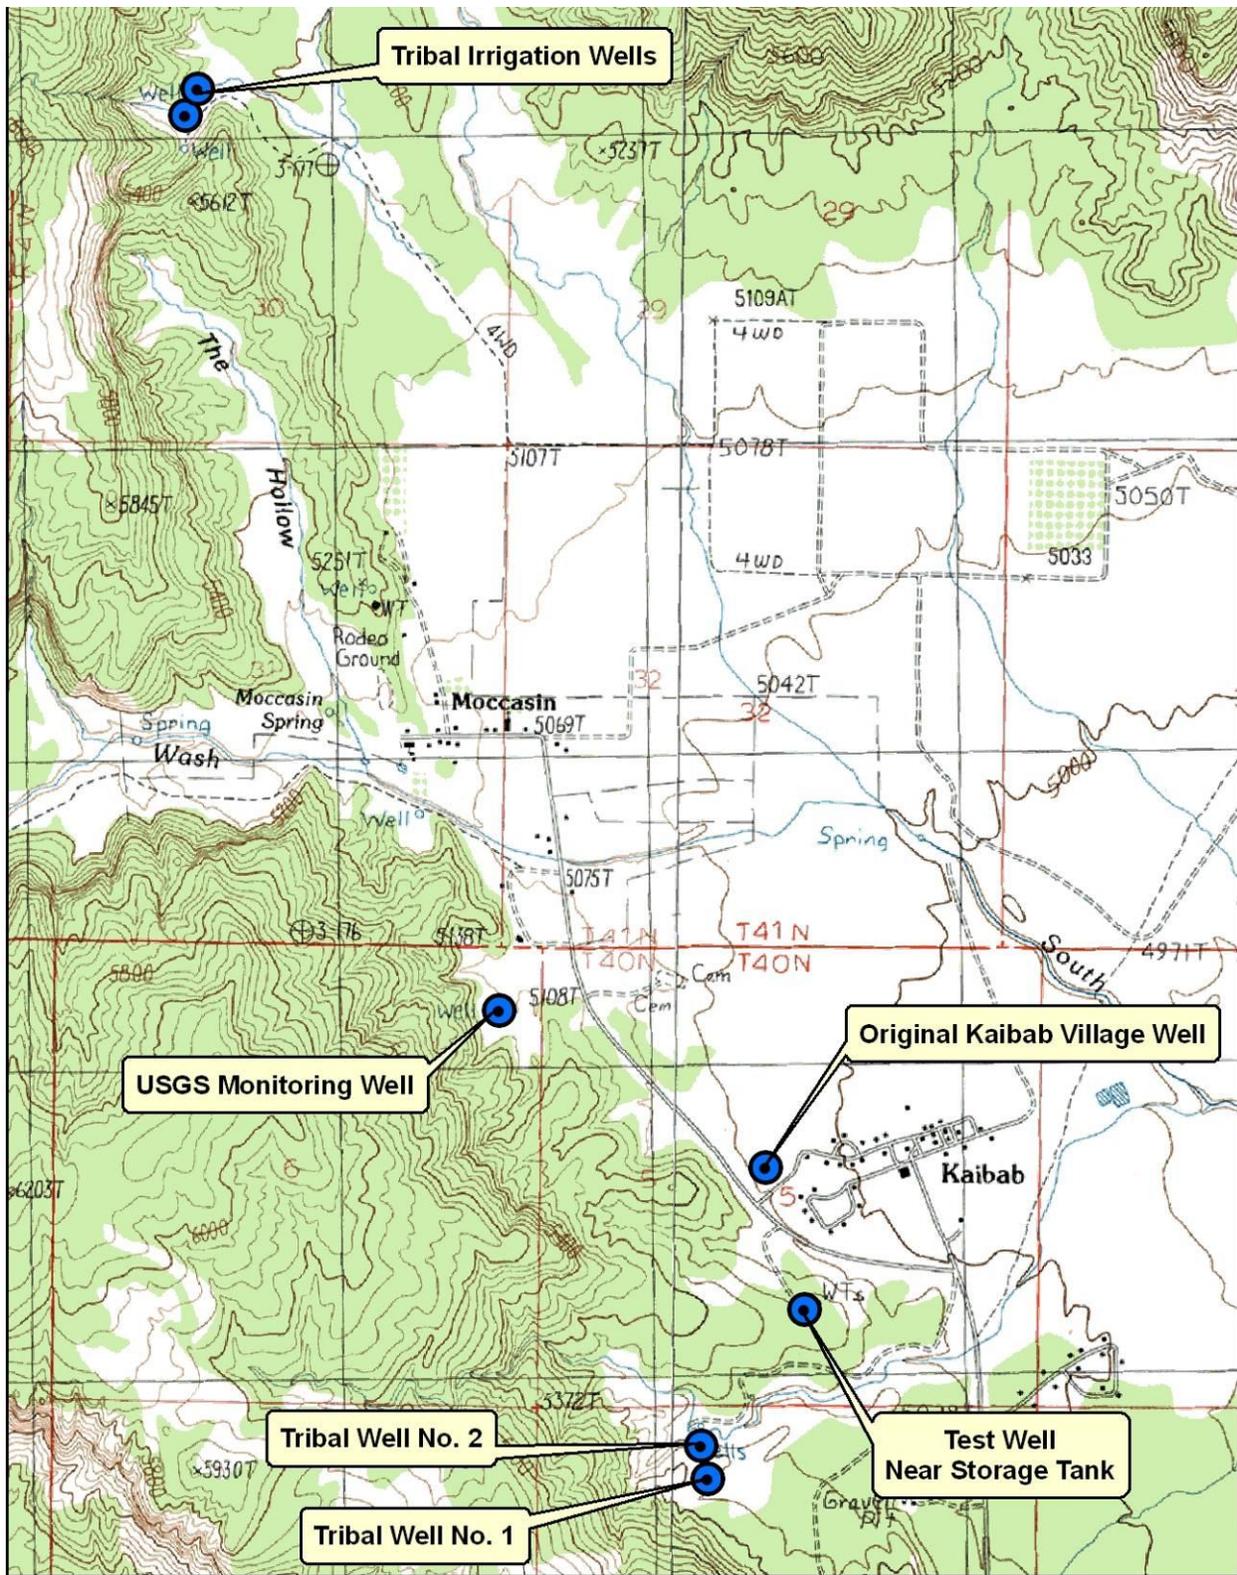
Figure 2. Location of Tribal test wells and supply wells.

By 1975, the Tribe had determined that the original well at Kaibab Village (Figure 2) was no longer adequate (McKoy, 2000). A test well was drilled about 1300 feet northeast of the NPS well (on the hill near the current location of the water storage tanks southwest of Kaibab Village), but it reportedly was dry at a depth of 290 feet and was abandoned. A second test well was drilled to 155 feet about 700 feet southwest of the NPS well and was completed by perforating the 6-inch steel casing from 92-142 feet (Tribal Well No. 1). Tribal Well No. 1 has not been pumped for many years, probably since 1980. The well still exists and is occasionally used as a monitoring well, but a bend in the casing prevents installation of a pump. The Tribe constructed a second well at this location (700 feet SW of the NPS well) in 1980 (Tribal Well No. 2). Tribal Well No. 2 is 250 feet deep and has three 10-foot sections of 0.040" well screen from 156-166, 176-186, and 196-206 feet below ground surface (WRD files and McKoy, 2000). Tribal Well No. 2 has been the sole source of water for the tribal water system since it was constructed. The locations of wells discussed in this paragraph are shown on Figure 2.

Although the NPS water supply well (T-6 on Figure 1) and the Tribal Well No. 2 (Figure 2) are located only about 700 feet apart (Figure 13), they supply two completely independent storage and distribution systems. The systems can be interconnected if either well is inoperative, but under ordinary circumstances the two systems are operated independently. The NPS well pumps water to a buried 500,000-gallon reservoir located about a half mile south of the NPS well. Water from the NPS well is then distributed to the NPS facilities at the monument, the Tribal-NPS partnership visitation center, and Tribal facilities including; the multi-purpose building, the NPS-leased administration building, campground, Red Hills Village, Tribal Court building, Red Cliffs gas station and convenience store, and the Tribal administration building. The Tribal well pumps water to storage tanks with a combined capacity of about 100,000 gallons on the hilltop about 1000 feet northeast of the NPS well. Water from the Tribal well is used primarily to supply the water needs at Kaibab Village and Juniper Village.

The USGS and BIA conducted a study to inventory existing water resources on the Reservation and constructed two test wells in August 1975. Test well locations are shown on Figure 2. The first well was completed in the Kayenta Formation about a half mile south of Moccasin and has commonly been referred to as the “USGS Monitoring Well.” The second well was completed in the Navajo Sandstone about a mile north of Moccasin and is one of the “Tribal Irrigation Wells.” Both wells are located very close to the Sevier Fault where fracturing of the rocks causes larger permeability.

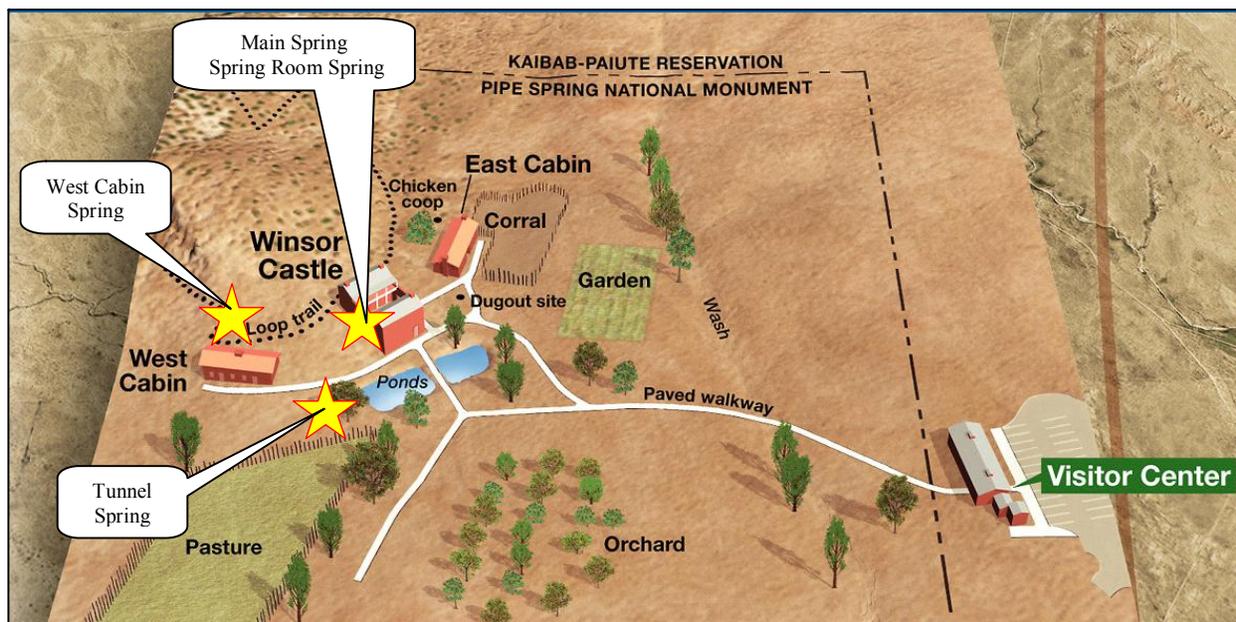
Figure 3. Spring flow monitoring locations at Pipe Spring.

Spring flow data have been reported for three distinct locations at Pipe Spring (Figure 3). West Cabin Spring is a small, undeveloped spring discharging on the hillside above West Cabin. It is about 400 feet west of Winsor Castle. Tunnel Spring is a horizontal adit that was constructed into the hillside between 1902 and 1907 to capture diffuse spring flow. Main Spring and Spring Room Spring are really part of the same spring outlet, the cistern in the courtyard of Winsor Castle. Water is piped from the cistern to the Spring Room and to Main Spring. Main Spring is outside the castle walls.

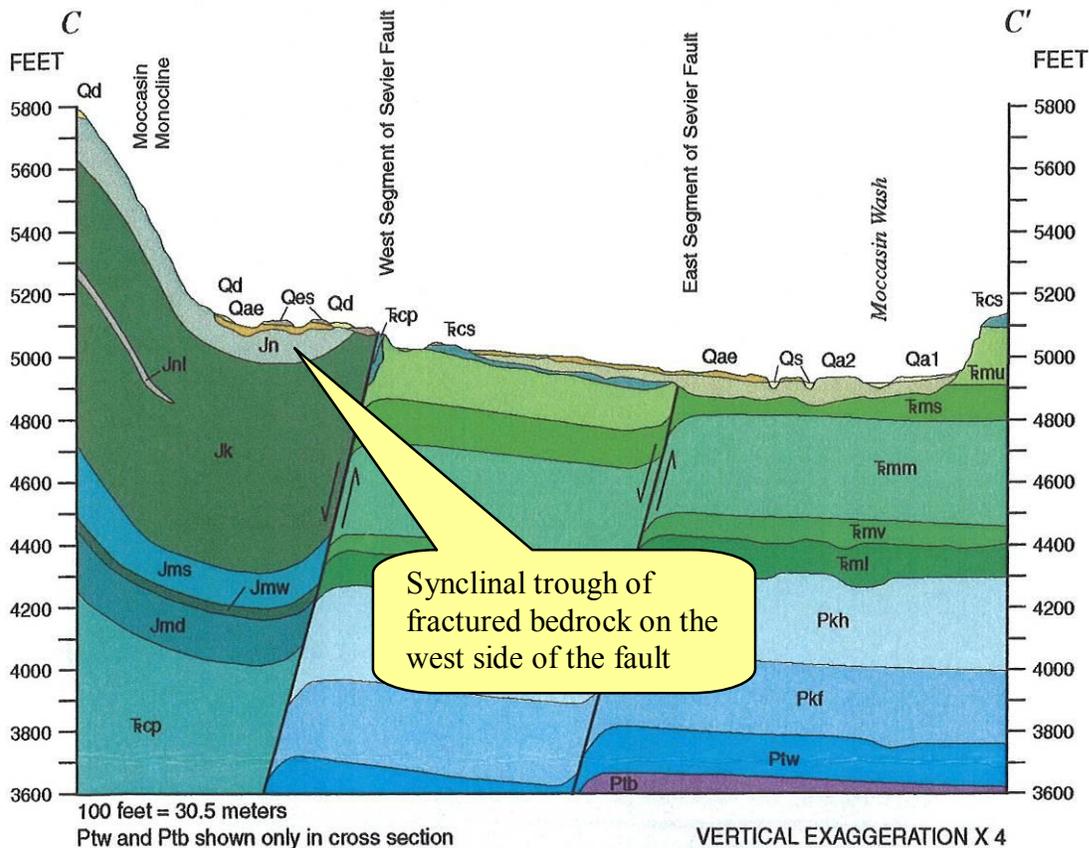
Figure 7. Southwest-Northeast geologic cross section through the Pipe Spring area. From Billingsley, et al., 2004.

Billingsley, Priest, and Felger produced a geologic map covering the four quadrangles surrounding Pipe Spring National Monument (Moccasin, Kaibab, Pipe Valley, and Pipe Spring). They provided a detailed description of the geologic structure associated with groundwater flow to the springs. The West Branch of the Sevier Fault branches from the main segment of the fault about 1 mile north of the monument. The Moccasin Monocline occurs along the west side of the West Branch of the Sevier Fault, dipping toward the east at about 10 degrees. At the base of the monocline, immediately to the west of the fault, is a small syncline that parallels the strike of the syncline. These geologic structures effectively form a trough bounded on the east by relatively impermeable rocks; creating a preferred pathway for groundwater flow. These features and geologic structure are shown on Figure 7.

1. Are on the down-thrown (west) side of either the West Branch or Main Branch of the Sevier Fault.
2. Discharge at the bottom of the syncline at the base of the east-dipping Moccasin Monocline.
3. Occur at or near the contact between the Navajo Sandstone and the underlying Kayenta Formation.
4. Are associated with north-south or northwest-southeast oriented bedrock joints.

Groundwater flow occurs primarily in the lower part of the Navajo Sandstone and upper part of the Kayenta Formation, mostly in the syncline at the base of the Moccasin Monocline. The relatively impermeable rocks of the Chinle and Moenkopi Formations on the east side of the West Segment of the Sevier Fault form an effective barrier to the easterly flow of groundwater, forcing the groundwater to flow south in the syncline. Moccasin Wash has eroded deep enough to intercept much of the groundwater flowing south in the syncline, creating Moccasin Spring and providing a source of recharge for the alluvial sediments in South Moccasin Wash. Discharge at Pipe Spring is similar in that a small drainage (Heart Canyon) has eroded headward into the syncline about ¼ mile northwest of Pipe Spring, allowing groundwater to flow east and southeast from the eroded syncline adjacent to the fault.

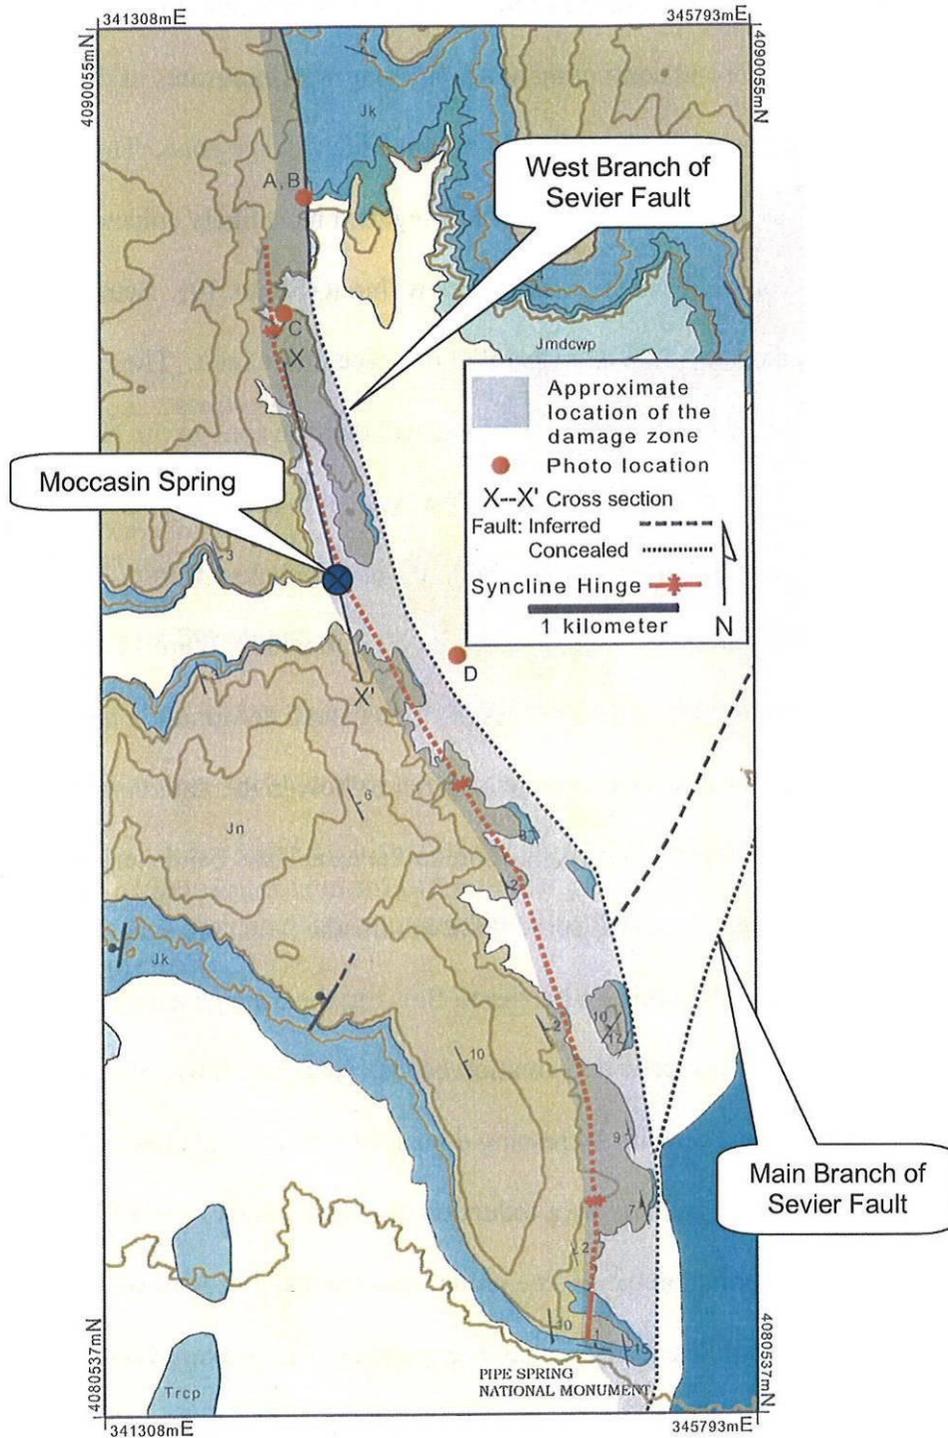
Figure 8. Location of fracture zone associated with the West Branch of the Sevier Fault, Figure 19 in Sabol (2005).

Downward movement of the rock units on the west side of the fault has created a small synclinal trough that parallels the traces of the faults from Pipe Spring National Monument to just north of

the Tribal irrigation wells. Groundwater flow from north to south in the synclinal trough is enhanced by fracturing of the rock by movement along the fault zone. The fracture zone is about 1000-1600 feet wide (Figure 8).

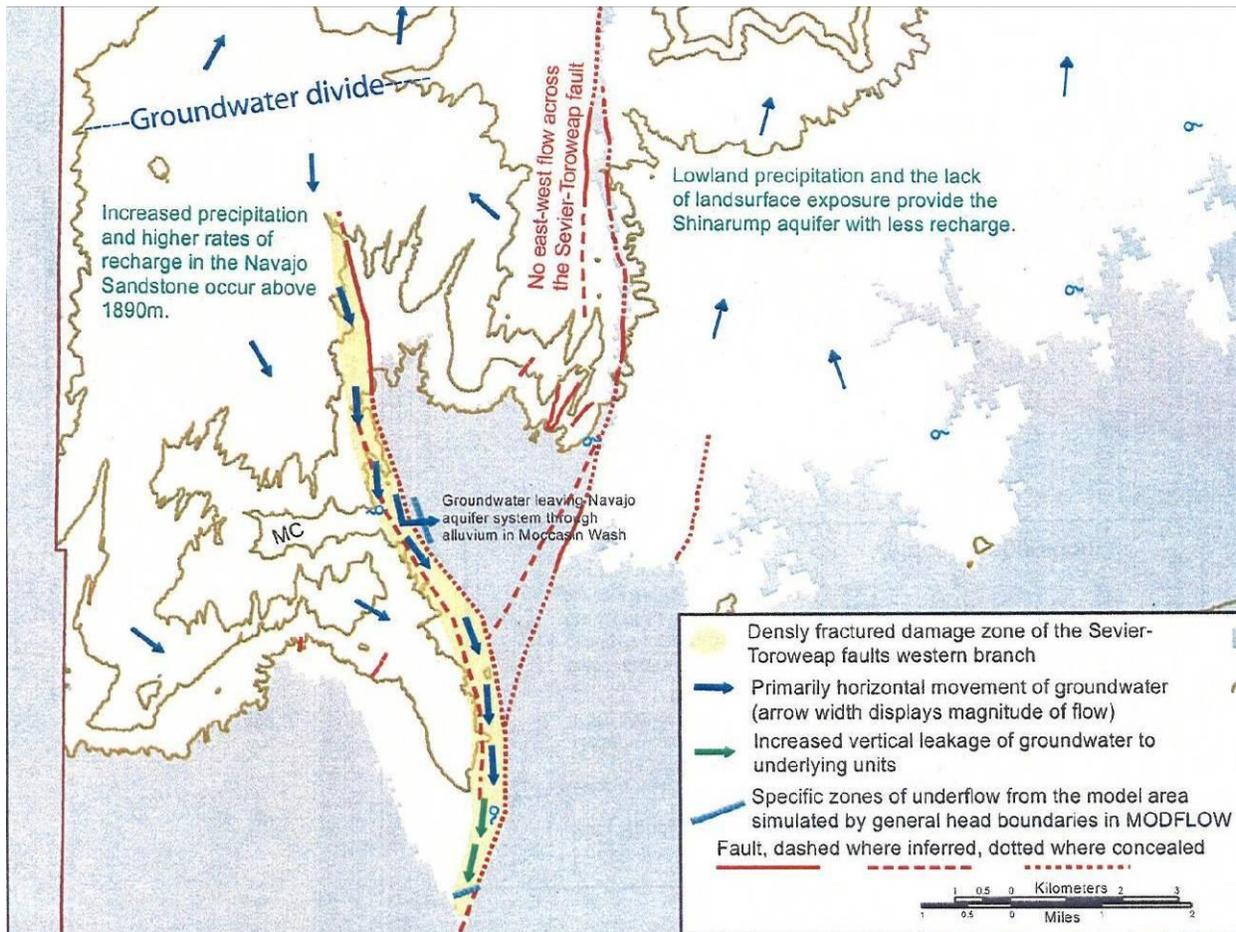
Figure 9. Conceptual model of groundwater flow showing north to south flow in the synclinal trough of fractured rock associated with the Sevier Fault. Also shown is the interception of groundwater by the alluvium in Moccasin Wash. Figure 21 in Sabol (2005).

Geomorphology and geology play important roles in the groundwater flow system. Moccasin Canyon separates the Navajo aquifer into two nearly separate systems north and south of the canyon. Where the synclinal trough associated with the West Branch of the Sevier Fault crosses Moccasin Wash, the wash and the alluvium filling the wash cuts across the saturated zone of the Navajo aquifer. The alluvium filling Moccasin Wash has a lower permeability than the fractured rocks of the Navajo aquifer and impedes groundwater flow from north to south along the fault zone, causing some of the water to discharge at Moccasin Spring on the north side of Moccasin Wash (Figures 9 and 10). Additionally, the nearly complete erosion of the Navajo Sandstone part of the aquifer greatly reduces the cross-sectional area of the groundwater trough creating a restriction to the flow of groundwater from north to south across the wash and forces some of the groundwater to emerge at Moccasin Spring. The alluvium in Moccasin Wash is partially saturated by infiltration of water from Moccasin Spring and underground flow from the Navajo aquifer directly into the alluvium. Much of the groundwater in the alluvium of Moccasin Wash flows downstream, to the east, and exits the groundwater flow system associated with the Sevier Fault. This water is no longer available to, or recoverable for, the springs at Pipe Spring National Monument.

Precipitation that infiltrates into the Navajo aquifer on Moccasin Mountain then flows easterly, following the dip of the geologic formation and is concentrated in the fractured rocks in the synclinal trough on the west side of the West Branch of the Sevier Fault. Additionally, the synclinal trough in the fractured rocks on the west side of the fault creates a preferential pathway for concentrating groundwater flow from north to south. At Pipe Spring National Monument, groundwater that is concentrated along the axis of the syncline either discharges at the springs or moves vertically downward into deeper bedrock formations.

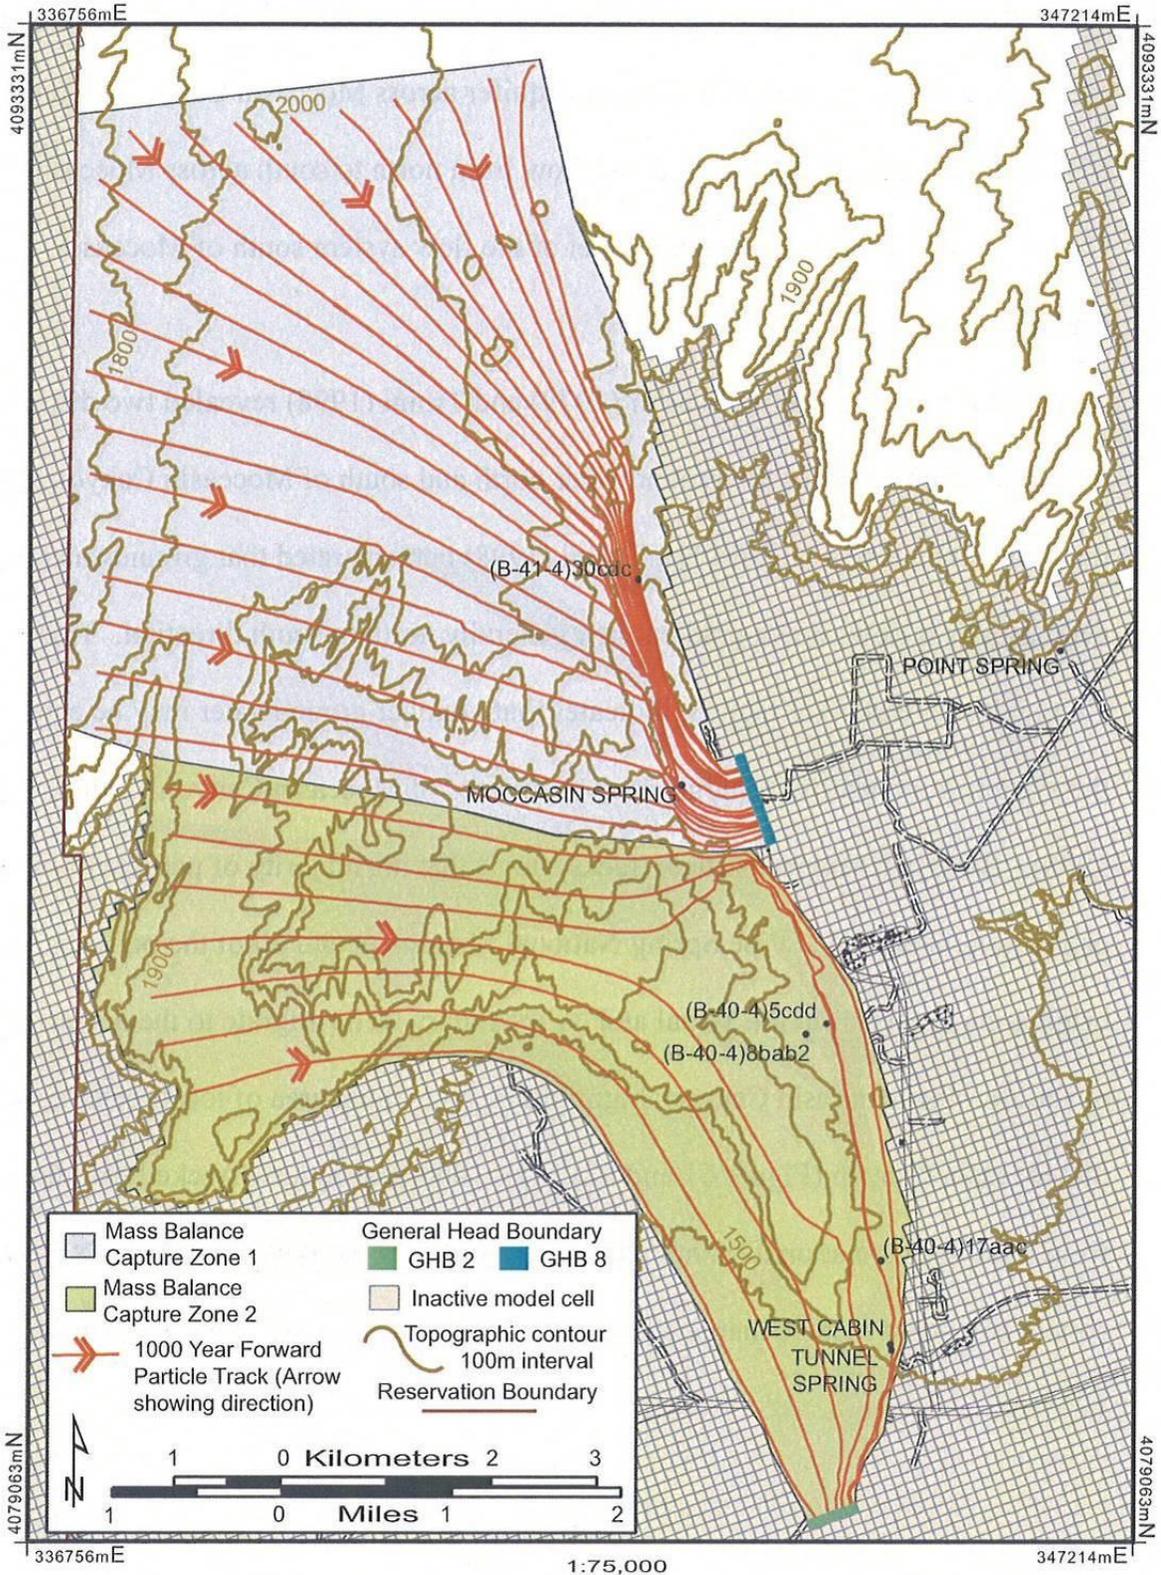
Figure 11. Capture zones for groundwater flow subsystems north and south of Moccasin Wash. Figure 60 from Sabol (2005).

Forward and reverse particle tracking showed that while most of the groundwater in the Navajo aquifer south of Moccasin Wash originates as recharge on that area of Moccasin Mountain lying to the south of Moccasin Wash (Figure 11), there is some contribution of groundwater from north of Moccasin Wash. Groundwater south of Moccasin Wash is a mixture of both local recharge from Moccasin Mountain to the west and inflow of groundwater from north of Moccasin Wash that migrates south toward the NPS and Tribal potable supply wells and the springs at the monument.

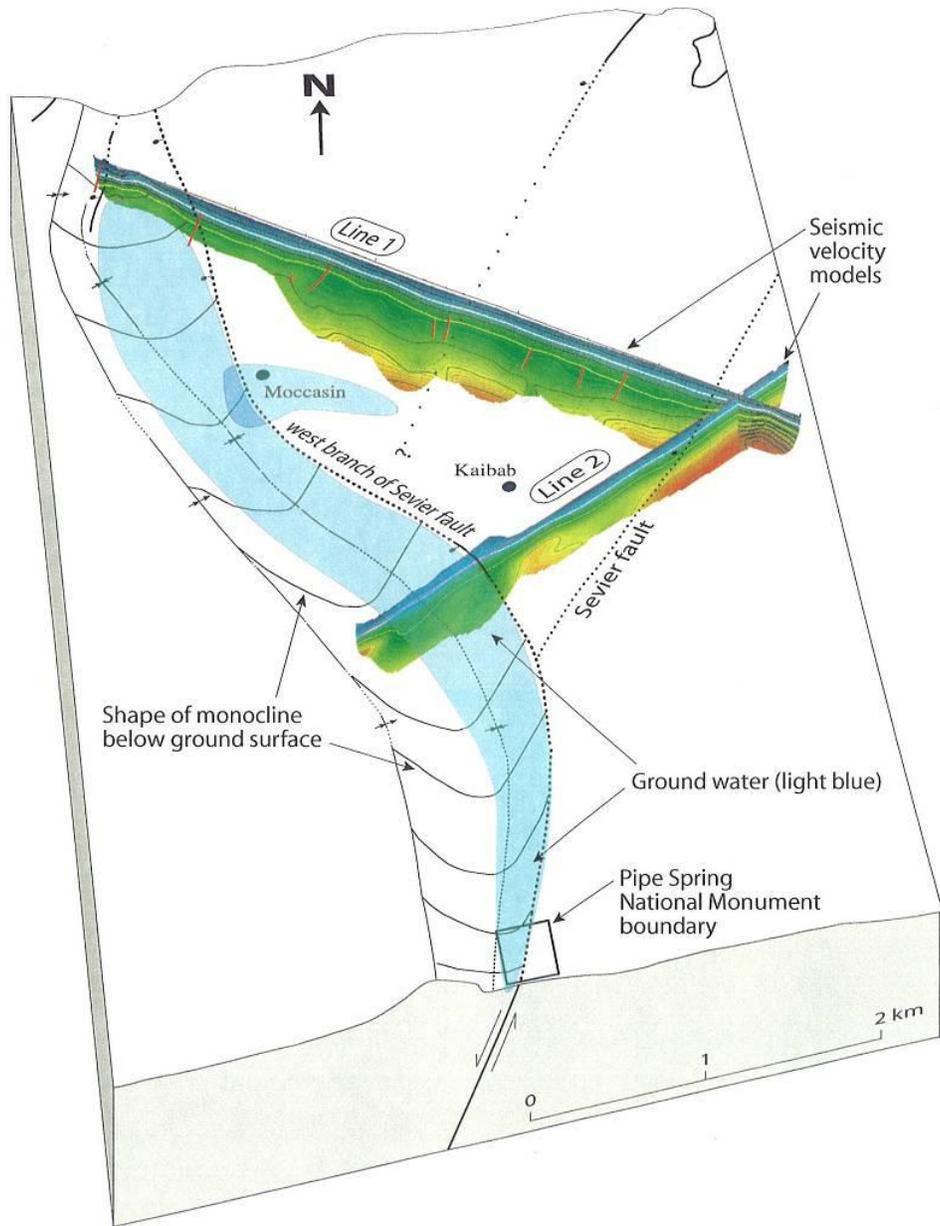
Figure 12. Geologic structure and hydrology, as determined from seismic profiling.  
From Rymer et al., 2005

The high resolution reflection and refraction profiling, combined with the geologic mapping of Billingsley, allows production of a three-dimensional picture of where and how groundwater is constrained by geologic structure in the area (Figure 12). Rymer et al. (2005) also concluded that other geologic structures for groundwater storage and flow are not likely to occur in the area.

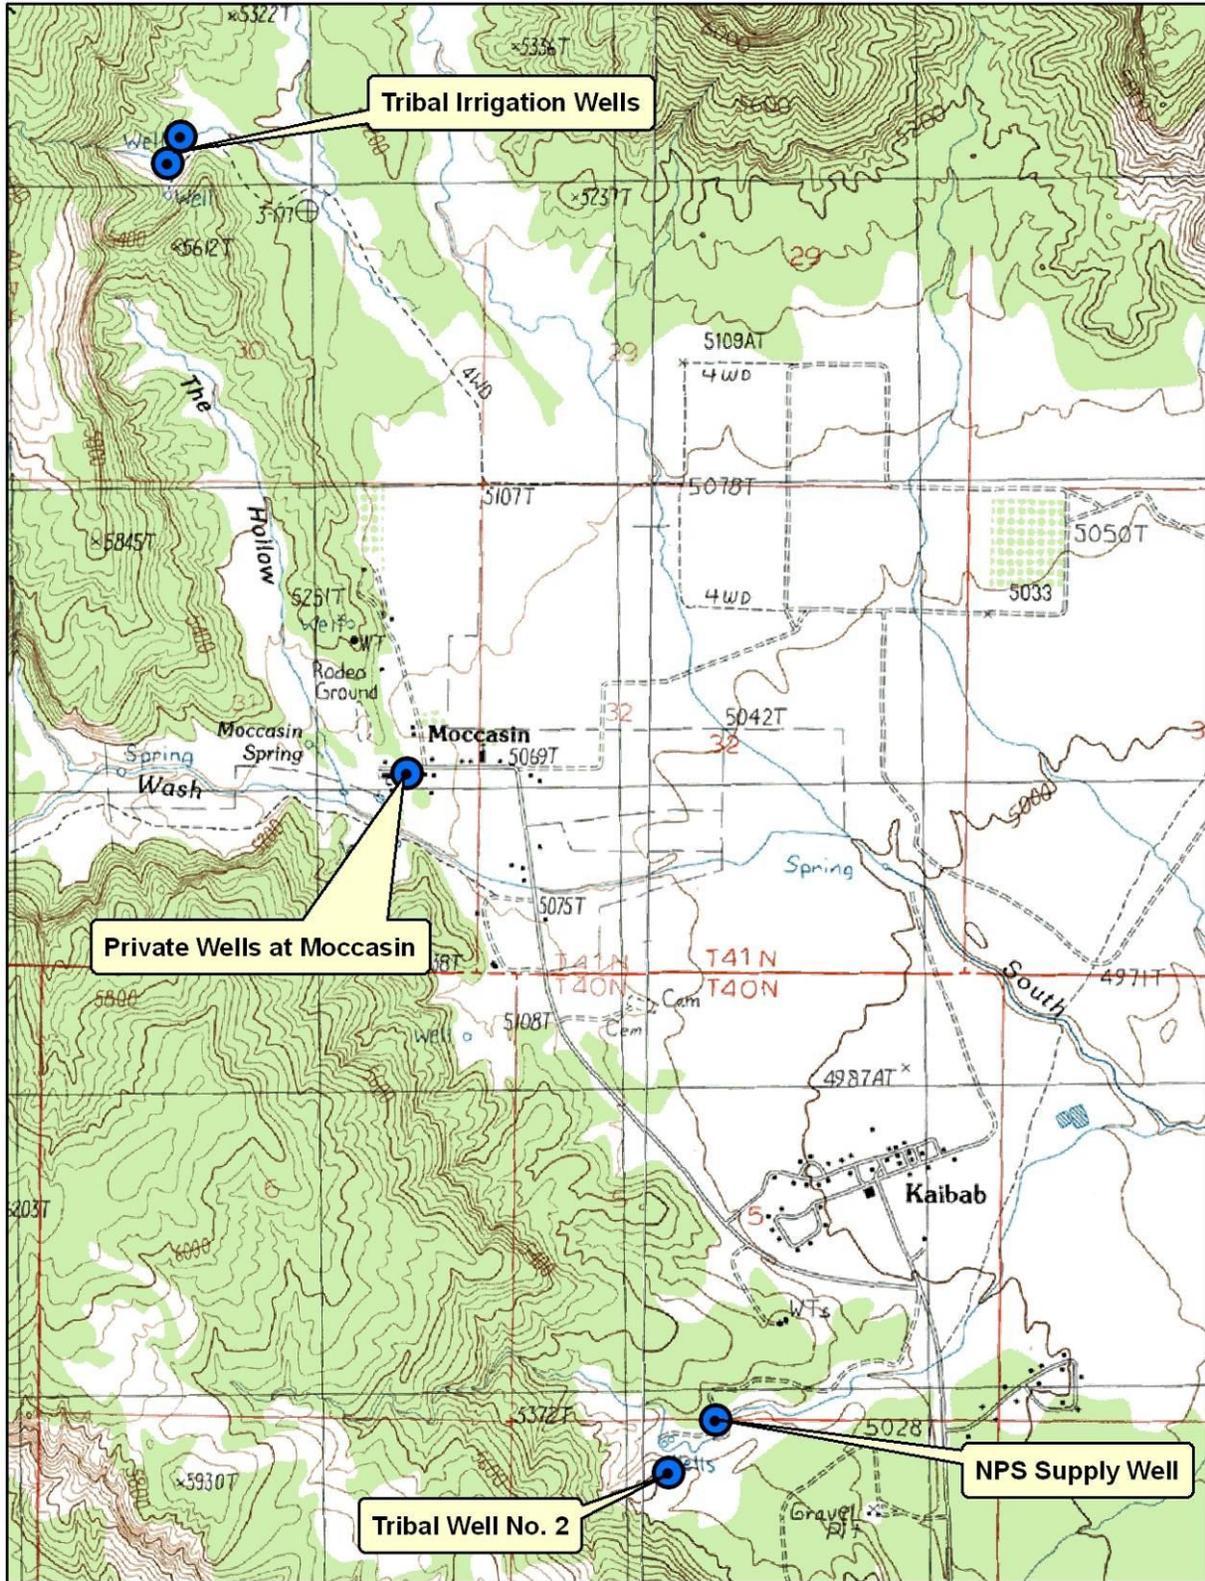
Figure 13. Location of water supply wells near Pipe Spring.

Groundwater pumping in the Pipe Spring area can be grouped into four categories; pumping from the NPS Well, pumping from the Tribal Well, pumping from private wells in the Moccasin area, and pumping from the Tribal irrigation wells north of Moccasin. The locations of these wells are shown on Figure 13.

The Tribal water supply well is completed in the fracture zone associated with the West Branch of the Sevier Fault. It is located about 700 feet southwest of the NPS Well. The Tribal Well is primarily used to supply water for residential use at Kaibab Village and Juniper Village; including the new Tribal Park and its irrigated ballfields and pow-wow grounds. NPS has no data regarding the amount of water pumped from this well.

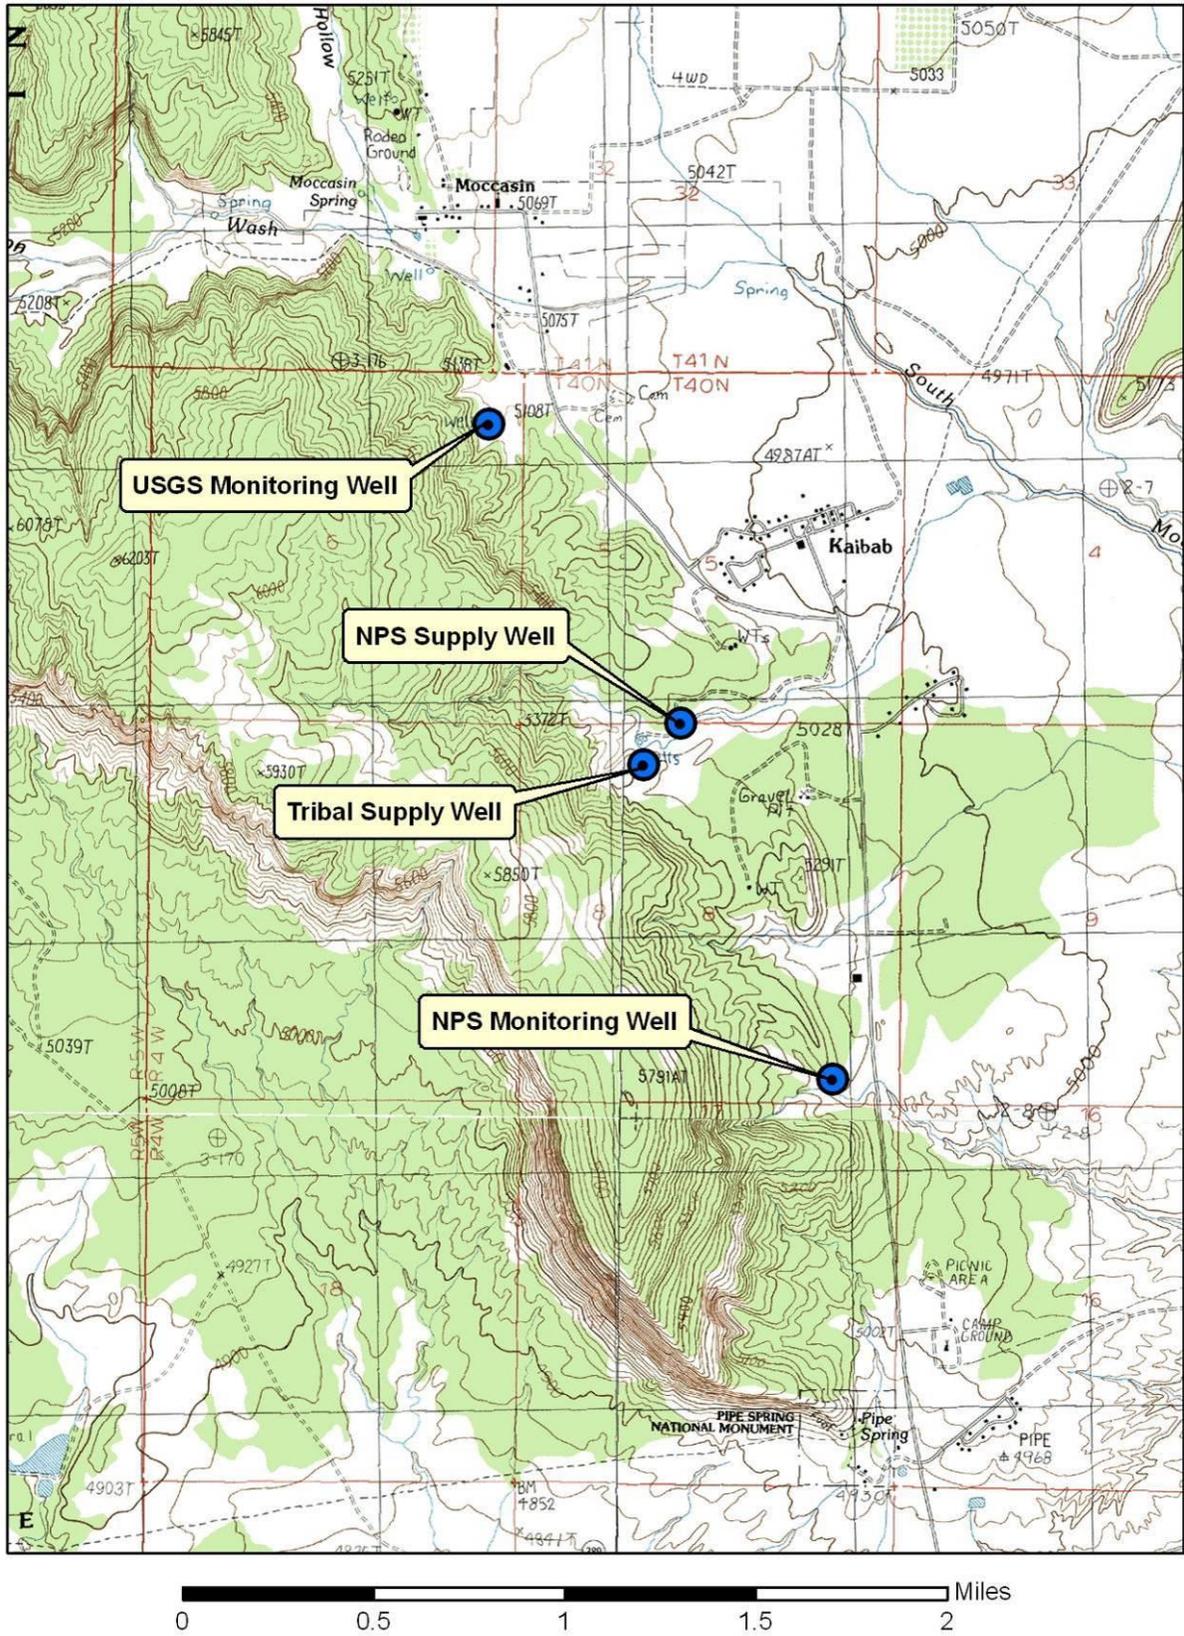
Figure 18. Location of water level monitoring wells and water supply wells near Pipe Spring.

Water levels in the Navajo Sandstone in the vicinity of the Tribal and NPS potable supply wells have been monitored regularly for many years. The USGS monitoring well is located about 1 mile northwest of the supply wells and about ½ mile south of the town of Moccasin (Figure 18). Water levels have been measured at the USGS monitoring well since 1976. The NPS monitoring well was constructed in 1989. It is located about a mile south of the supply wells and a mile north of the monument (Figure 18).

Water levels in both monitoring wells show a general decline of about a third of a foot per year (Figure 19). Water levels in the immediate vicinity of the supply wells have not been regularly measured. The observed water table decline at the two monitoring wells, both about a mile from the supply wells, indicates a general decline of the water level in the aquifer encompassing a large area. This decline may be the cause of spring flow decline at Pipe Spring. As the water level in the aquifer is lowered, there is less of an elevation change between the water level in the aquifer and the springs, and therefore, it would be expected that discharge at the springs would decrease.

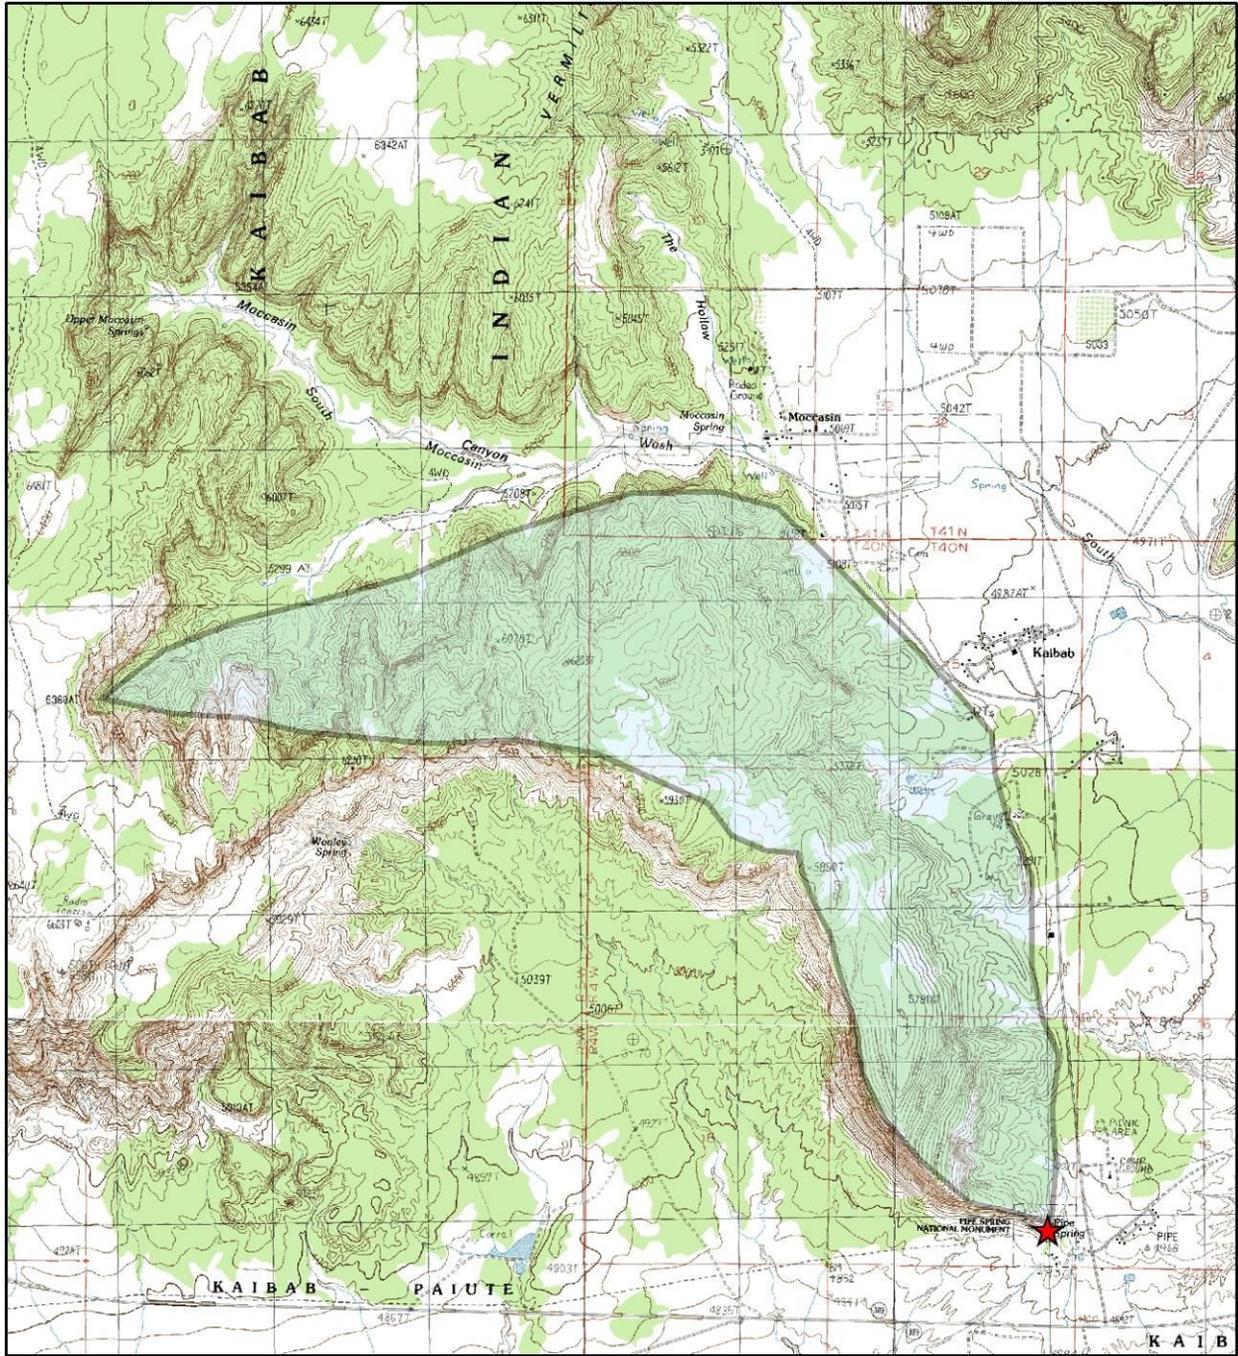
Figure 20. Possible recharge area for the springs at Pipe Spring National Monument (modified from Sabol, 2005).

One of the questions to be addressed is whether the pre-development water budget for the springs at Pipe Spring could be balanced using only recharge from south of Moccasin Wash. Mapping the potential recharge area to be approximately coincident with the outcrop of the Navajo Sandstone on that part of Moccasin Mountain that is south of Moccasin Wash and west of the fault shows the potential recharge area is greater than two square miles (Figure 20). I then assume that the recharge rate is 5% of the annual precipitation, well within the range of values reported for the Navajo Sandstone by other investigators. Multiplying the recharge rate by the area yields an annual recharge of 19 mgy to the local groundwater system (equivalent to 36 gpm). Thus it would appear that the entire predevelopment flow at Pipe Spring could be supplied by infiltration of a small percentage of precipitation on the east-facing slope of the mountain north and west of Pipe Spring and south of Moccasin Wash (Figure 20). Some additional inflow to the groundwater system likely occurs via the north-to-south flow of groundwater under Moccasin Wash from areas north of Moccasin.

Groundwater pumping must eventually be balanced by reducing outflow at the springs by an equivalent amount. Records for pumping of the NPS Supply Well show the average pumping rate to be around 25 gpm. The average pumping rate for the Tribal Supply Well is not available to us. However, a limited amount of data from April-June 2006 suggests that the combined groundwater pumping from both the Tribal and NPS potable supply wells is approximately 60 gpm. This estimate of 60 gpm is based on data from for two months in one year. We don't know what the usage was during that short period, or whether there was significant irrigation or not. Thus, the figure of 60 gpm should be used with a great deal of caution.

If the combined annual average pumping rate for the NPS and Tribal Supply Wells is more than the predevelopment flow rate at the springs (about 40 gpm), then spring flow at Pipe Spring will probably continue to decline until it ceases entirely.
