AN ASSESSMENT OF RIPARIAN AND UPLAND CONDITIONS ON GRAZING ALLOTMENTS AT LAKE ROOSEVELT NATIONAL RECREATION AREA, WASHINGTON

Technical Report NPS/NRWRD/NRTR-2005/329

April 2005

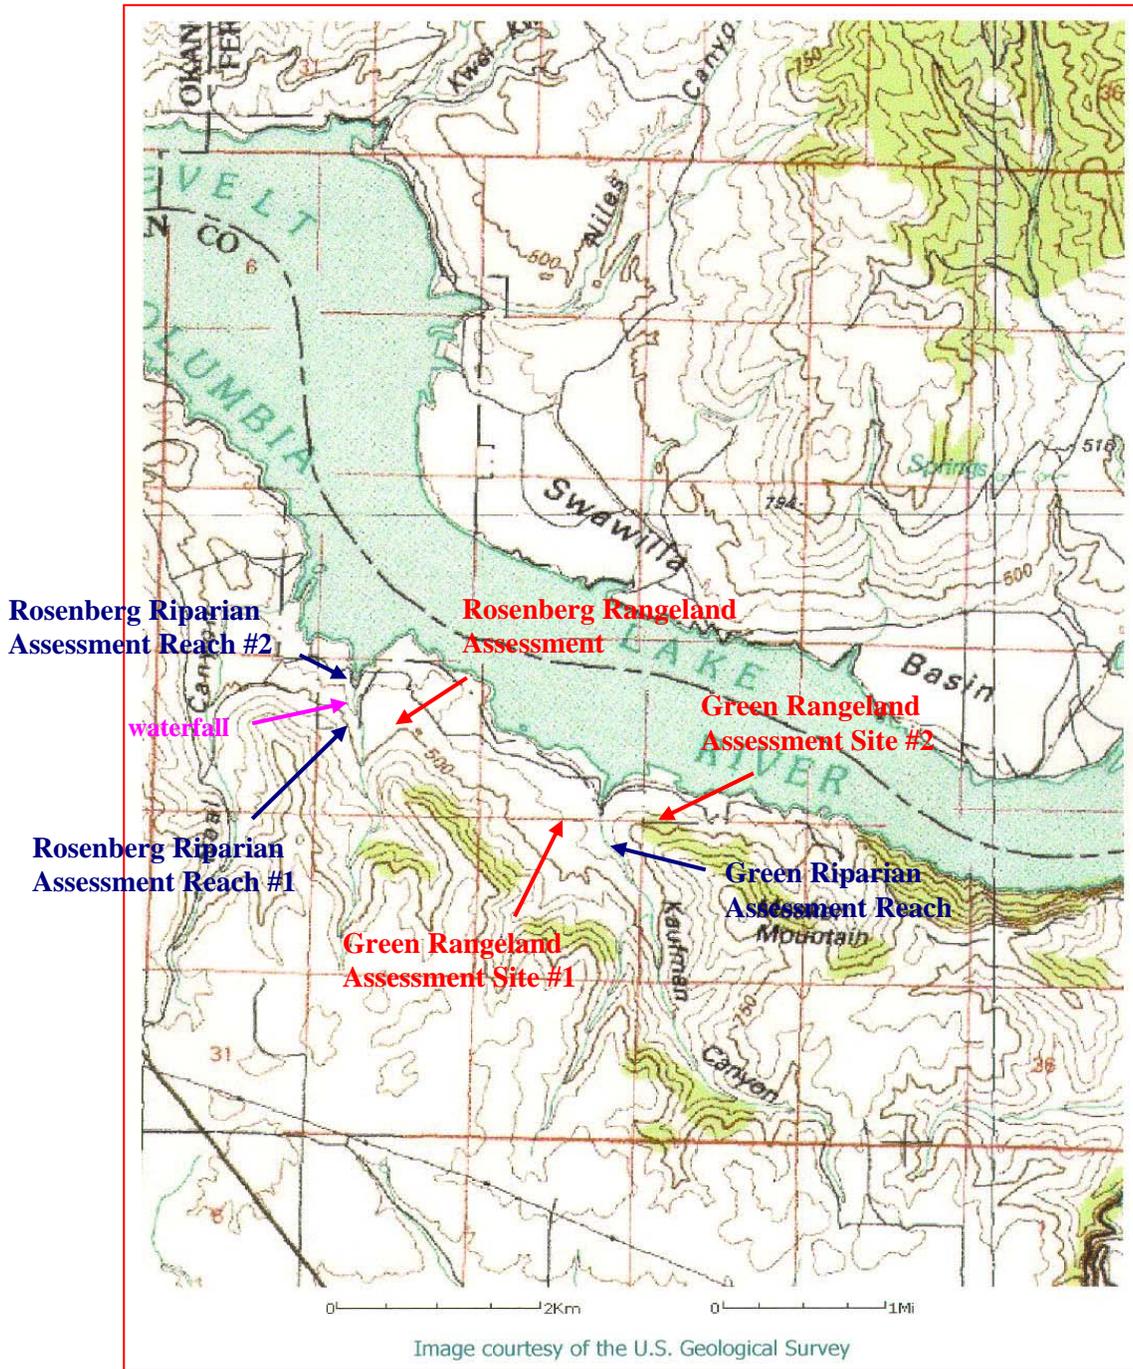
Figure 1. Locations of riparian and rangeland assessments within the Rosenberg and Green grazing allotments.

PFC assessment reaches are chosen based on similarity in valley and channel characteristics, land use, and other factors. In this case, a waterfall represents a significant break in channel type (bedrock bottom above the waterfall vs. alluvium below). Therefore, separate assessments were performed for stream reaches above and below the waterfall (Figure 1).

For this allotment we assessed a stream reach extending from the lakeshore to a point approximately 200 feet south of the Green property line (Figure 1). Unlike the V-shaped channel in the steeper-graded Rosenberg sites, this alluvial channel has an associated floodplain that supports a dense riparian vegetation community (Figures 4 and 5). Channel sinuosity, bed steps, and a well-vegetated floodplain combine to disperse the energy from flood flows and minimize erosion (no significant channel incision or lateral migration were observed). The width/depth ratio, sinuosity, and channel/floodplain form are all appropriate to the approximately 2% valley grade. This channel doesn’t appear to be subjected to high flows very often (no evidence of flood flows such as flood debris or bank scour), which may be related to very high infiltration rates in the watershed and small watershed area (same upland soil group as at the Rosenberg site).

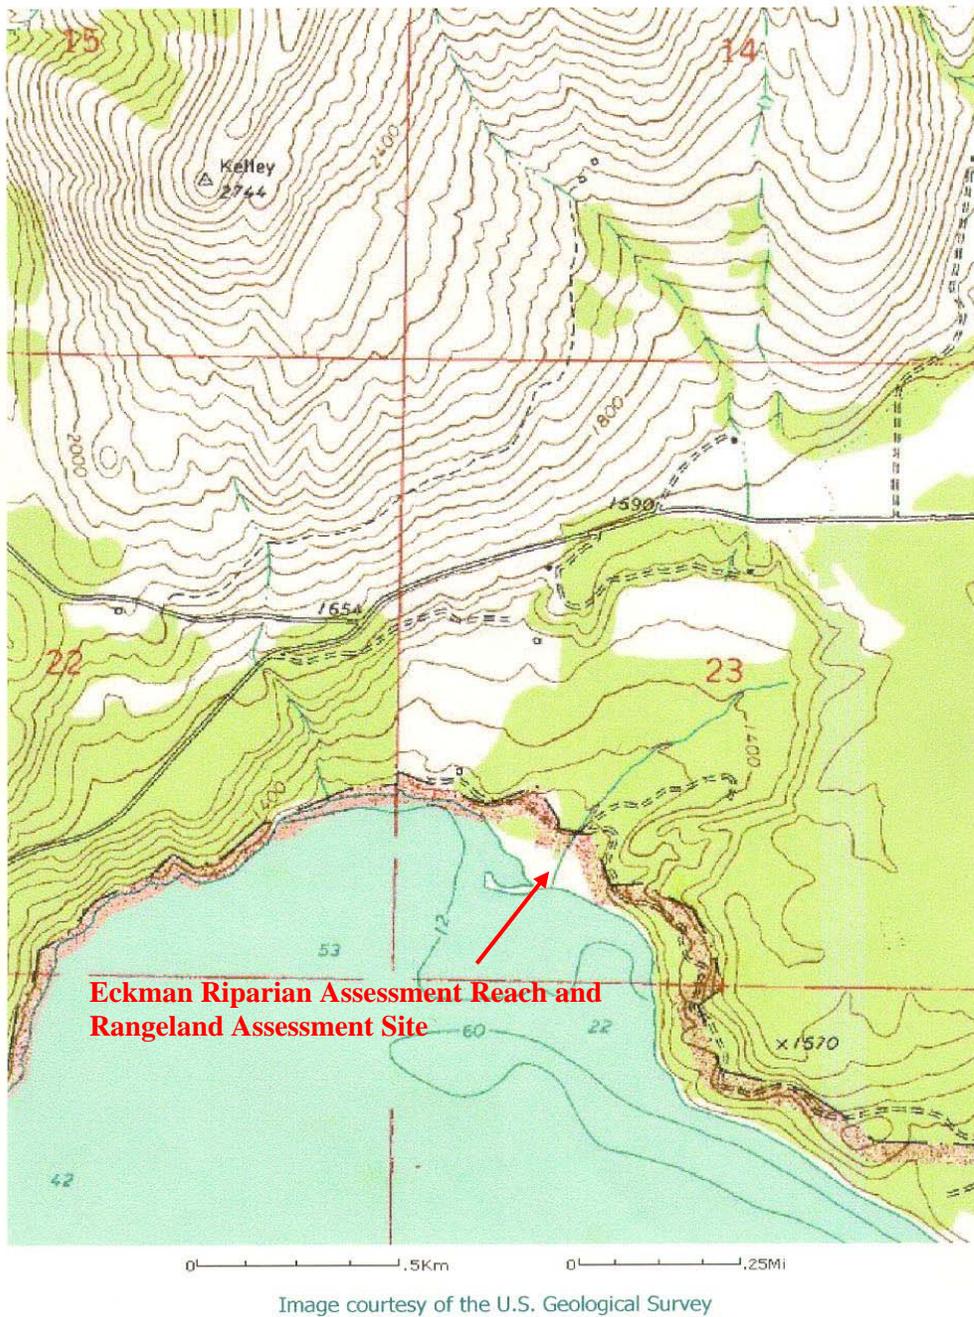
Figure 6. Locations of riparian and rangeland assessments within the Eckman grazing allotment.

We assessed the lowest portion of this stream, a reach extending 250 feet upstream from the lake shore (Figure 6). The channel is incised approximately 8-10 feet deep near the shoreline (Figures 7a and b), and an active headcut extends approximately 200 feet upstream. In this unstable reach, stream energy is dissipated through channel incision and bank erosion, resulting in a narrow, steep-walled channel with no floodplain. The banks are continuously failing and adding excess sediment to the channel and to the lake. This process appears to be exacerbated by cattle hoof action. If unchecked, the headcut has the potential to degrade much more riparian-wetland habitat upstream and to continue delivering excess sediment to Lake Roosevelt.
