Water Resources Foundation Report

Bandelier National Monument

Natural Resource Technical Report NPS/NRPC/WRD/NRTR—2007/060

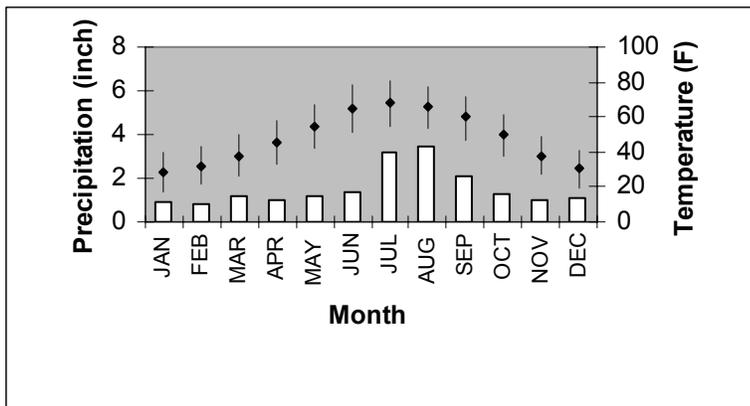
Figure 4. Monthly mean precipitation (bars) (1961-1990) and 24-hr average air temperature (diamonds) (1919-1989), Los Alamos, New Mexico (World Climate, 2007).

Recognizing that one climate station will not capture the climate variability within the national monument's boundaries, Figure 4 presents climate data for Los Alamos, New Mexico, which is in the middle of the elevation range at 7411 ft (msl). At this station, the annual average precipitation is 18.7 inches (World Climate, 2007). Typically, July and August are the wettest months (4.4 inches), when the intensive convective storms occur during the "monsoon" season. These summer thunderstorms have been responsible for the most extensive surface erosion and highest flood peaks on record (Reneau *et al.*, 1996). A dry period usually extends from late April through the end of June (Allen, 1989). Average monthly air temperatures range from 28.6° F (-1.9° C) in January to 67.8° F (19.9° C) in July (Figure 4) (World Climate, 2007).

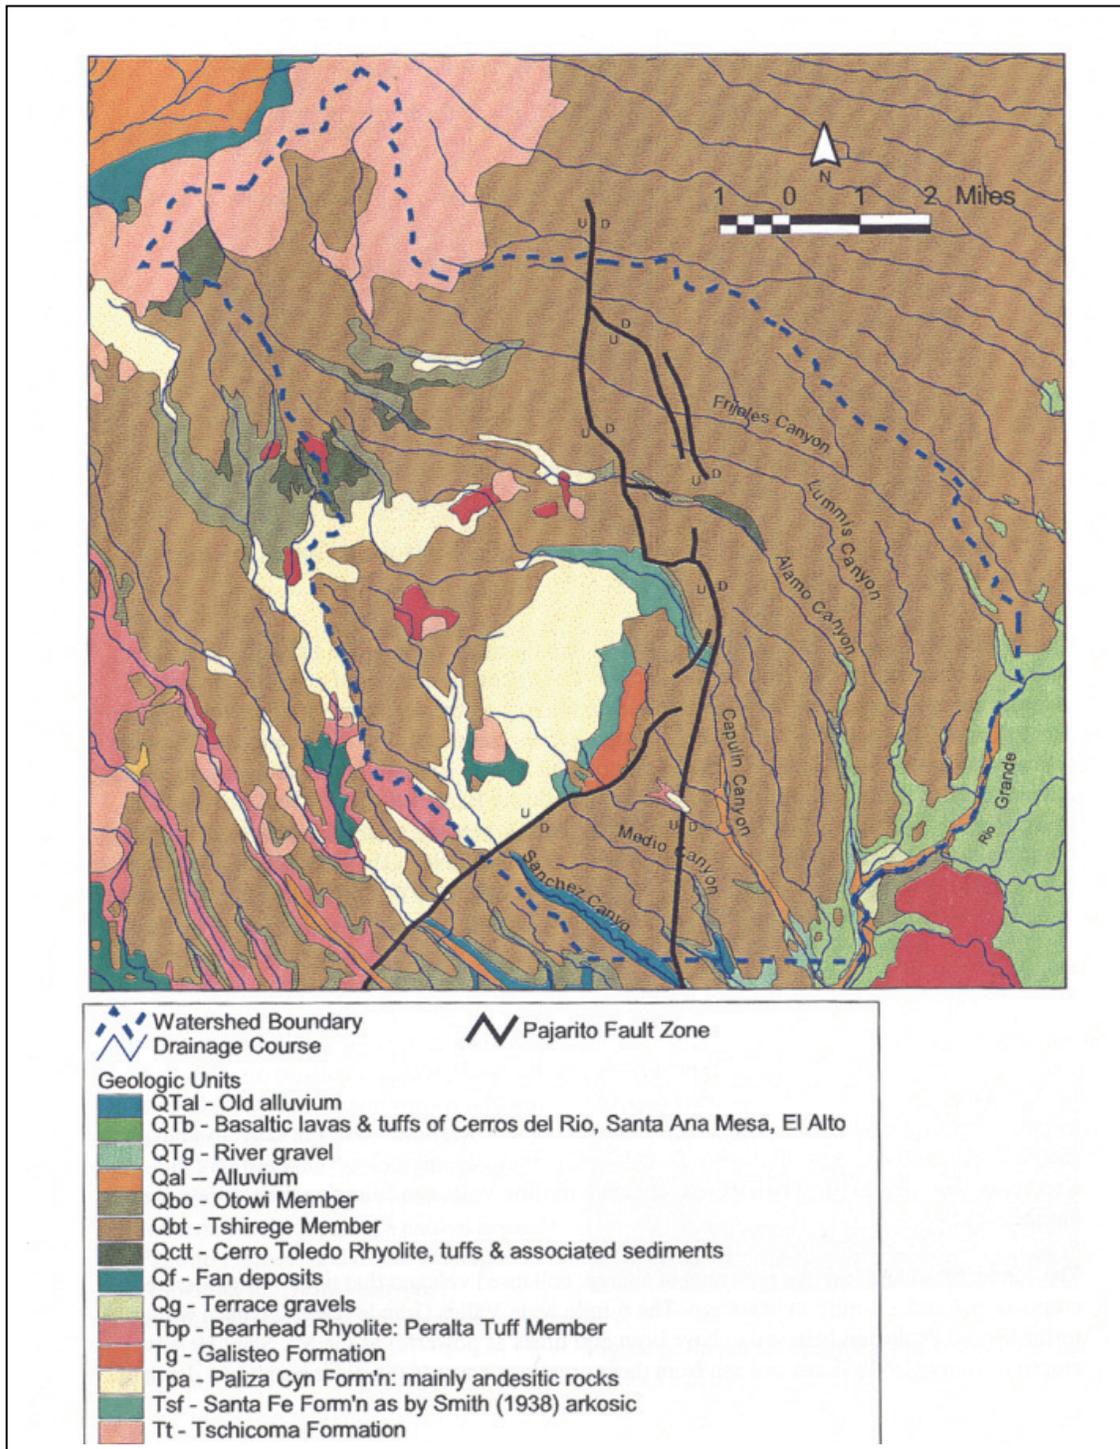
Figure 5. Surficial Geology at Bandelier National Monument (Bandelier National Monument – GIS).

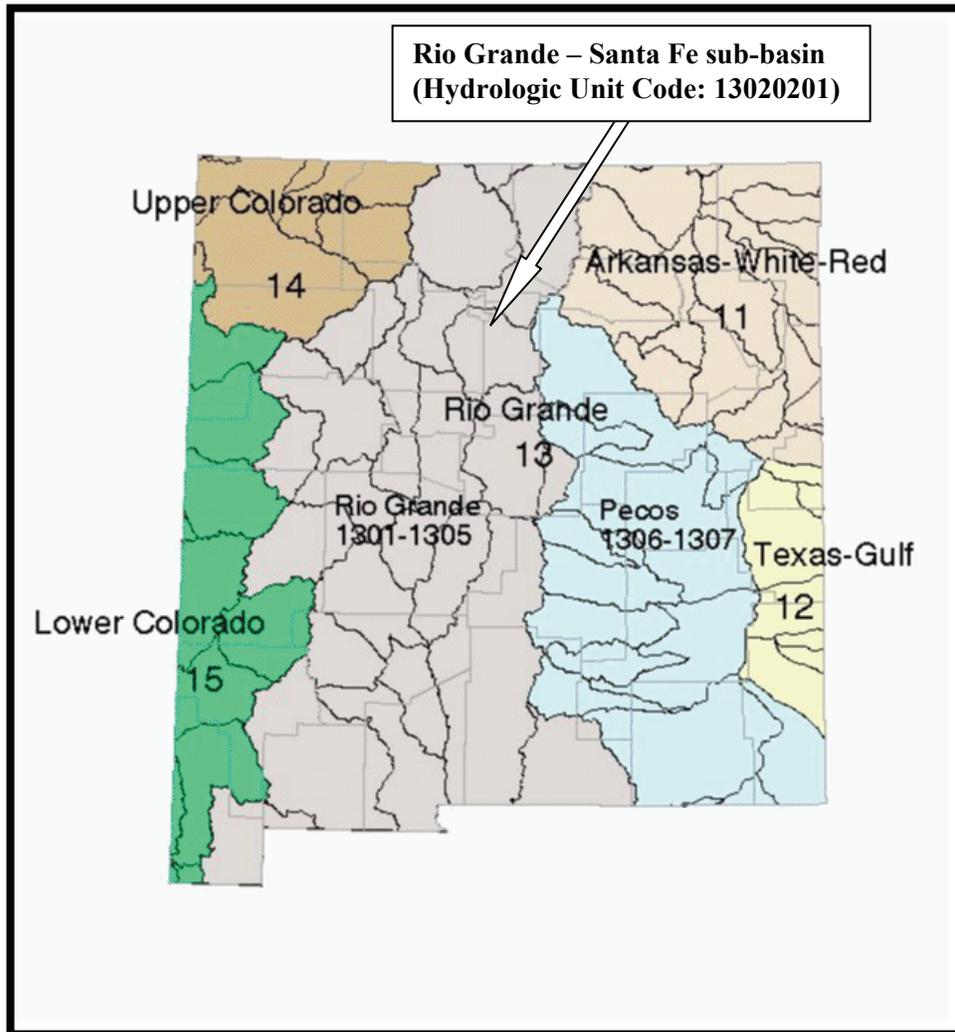
Figure 6. Location of the Rio Grande – Santa Fe sub-basin (13020201), which includes BAND (New Mexico Water Resources Research Institute, 2007).

Watersheds are delineated by the U.S. Geological Survey using a nationwide system based on surface hydrologic features. This system divides the country into 21 regions, 222 subregions, 352 accounting units, and 2,262 cataloguing units. A hierarchical hydrologic unit code (HUC) consisting of 2 digits for each level in the hydrologic unit system is used to identify any hydrologic area. The 6-digit accounting units and the 8-digit cataloguing units are generally referred to as basin and sub-basin, respectively. HUC's serve as the backbone for the country's hydrologic delineation. Within the HUC classification system, BAND is located in the *Rio Grande – Santa Fe* sub-basin (13020201) of Region 13, *Rio Grande*, (see Figure 6).
