Science Notes

Restoring hydrologic processes and protecting karst resources at Antietam National Battlefield

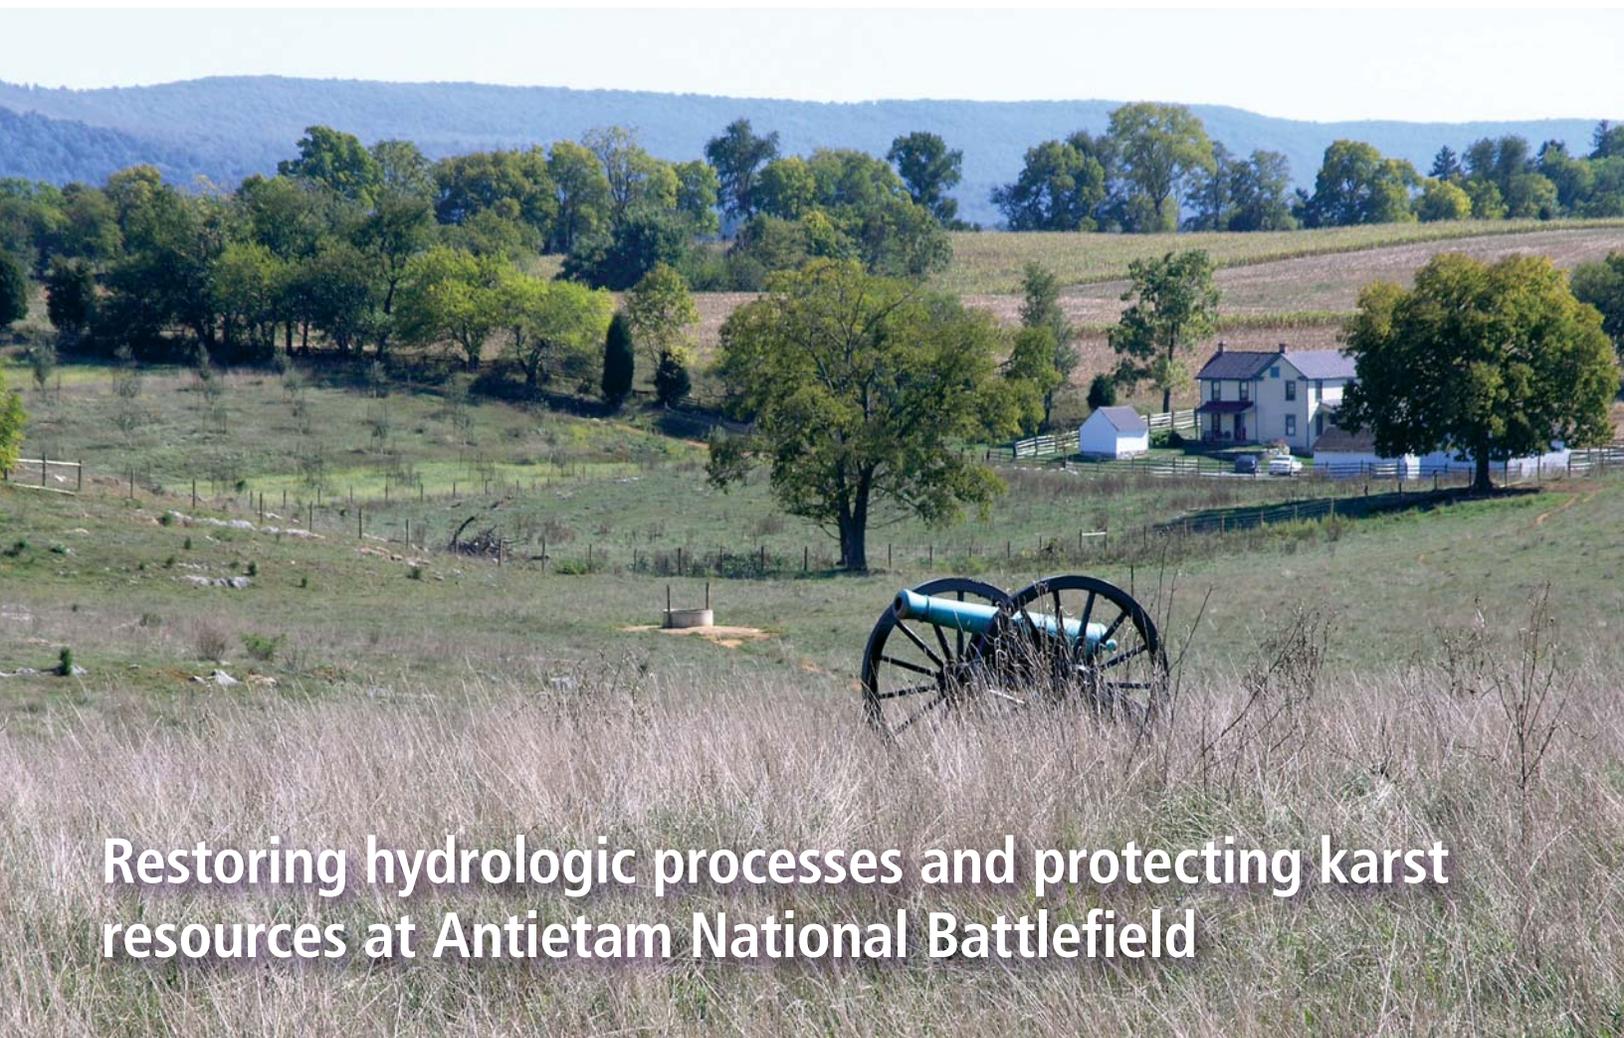
Figure 1. The Piper Farm at Antietam National Battlefield Park participates in an agricultural permit program designed to retain the appearance of the landscape at the time of the Civil War, when the area was used as pasture and for crop production. Cattle waste and poor drainage, however, created conditions that could have been polluting groundwater and nearby Antietam Creek. Pictured are the historical farmhouse, a cannon that marks the location of artillery at the time of the battle, and a recently replanted apple orchard.

Management Policies 2001 (and the more recently updated *Management Policies 2006*), managers implemented various best management practices, focusing on Antietam's historic Piper Farm (fig. 1).

The Piper Farm includes 105 acres (42 ha) of pasture with a carrying capacity of 55 cattle. Though the battlefield's special use permits require 2 acres (0.8 ha) per animal unit (cow/calf), the only water source was a single well-fed trough in a low-lying section of pasture. Over time, congestion of the animals in this limited space caused deteriorating ground conditions, which raised concerns about sedimentation, soil erosion, and contamination of surface water. Further adding to the problem was

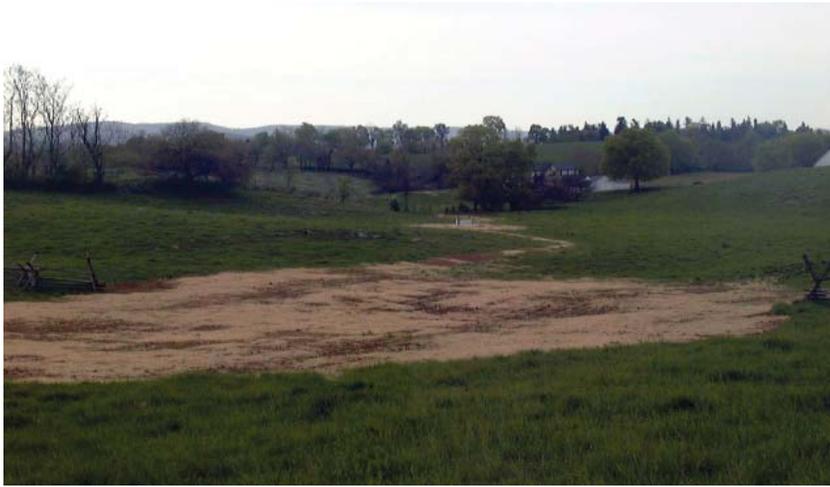
Figure 2. The restoration removed an intermittent pond and berm, improving drainage in the areas where cattle congregated. To disperse cattle, managers routed runoff to two troughs. The area was re-graded and seeded to complete the project, safeguarding groundwater and streams of the Chesapeake Bay watershed. NPS

an abandoned farm pond once fed by a system that historically drained adjacent fields. All that was left of the pond and old drainage system were a constructed berm and an exposed pipe that fed directly into the pasture. The resulting condition was a “wetland” that collected stagnant water and animal waste from congregating cattle. During wet weather, runoff from the site would flow over the pasture through an intermittent streambed that emptied into Antietam Creek. Considering the karstic nature of the area, contamination of groundwater was also likely. Antietam staff became increasingly concerned about the area and started to look for a way to both move the cattle's water source and eliminate the remnants of the pond. Park staff pursued a cost-

As a result of consultation with the Washington County Soil Conservation District, park staff developed two objectives and corresponding remediation projects. The first was to create two gravity-fed troughs in two pastures using the inflow of water from the old drainage system, grade the pond area to a more natural appearance, and dismantle the berm, eliminating the collection area for water (fig. 2). A new PVC pipe would connect to the existing outlet of the old system and carry the water away from this area to trough number 1 in the same pasture. The overflow from the first trough would then travel through a PVC pipe to fill trough number 2 in the far pasture adjacent to the Piper orchard. Any overflow from the second trough would be routed via PVC pipe to a natural stream channel. Fencing and a riparian buffer would protect this area. The second objective was to rehabilitate the barnyard and cattle chute area. With the two troughs relieving pressure from the current water source at the barnyard, contractors would re-grade and seed the area, following recommendations of the Washington County Soil Conservation District.

Park staff and cooperators successfully completed the project in May 2005. Two water sources now provide more flexibility for grazing operations and rotational grazing. The work was crucial because of the sensitive hydrologic system and because park waters eventually drain into Chesapeake Bay—the largest, most productive estuary in North America. The National Park Service partners with several states and agencies to protect and improve the bay and its resources; completion of the project supported this commitment. Today the water troughs are working as designed, the barnyard has less livestock pressure, and the water that once lay stagnant in the remnant pond is now on its way to Antietam Creek with a much reduced risk of pollution by livestock waste.
